UNITED STATES PUBLIC LAND SURVEY CORNER CERTIFICATE

Land Survey Monuments situated in Section **7**, Township **74** North,
 Range **28** West, of the Fifth Principal Meridian, **Madison** County, Iowa,
 Previously recorded in **Not Applicable** in County Recorder's Office

This certificate is being prepared because there are no certificates on file for these corners and these corners were used for a survey in this section for Iowa Select Farms L.L.P.

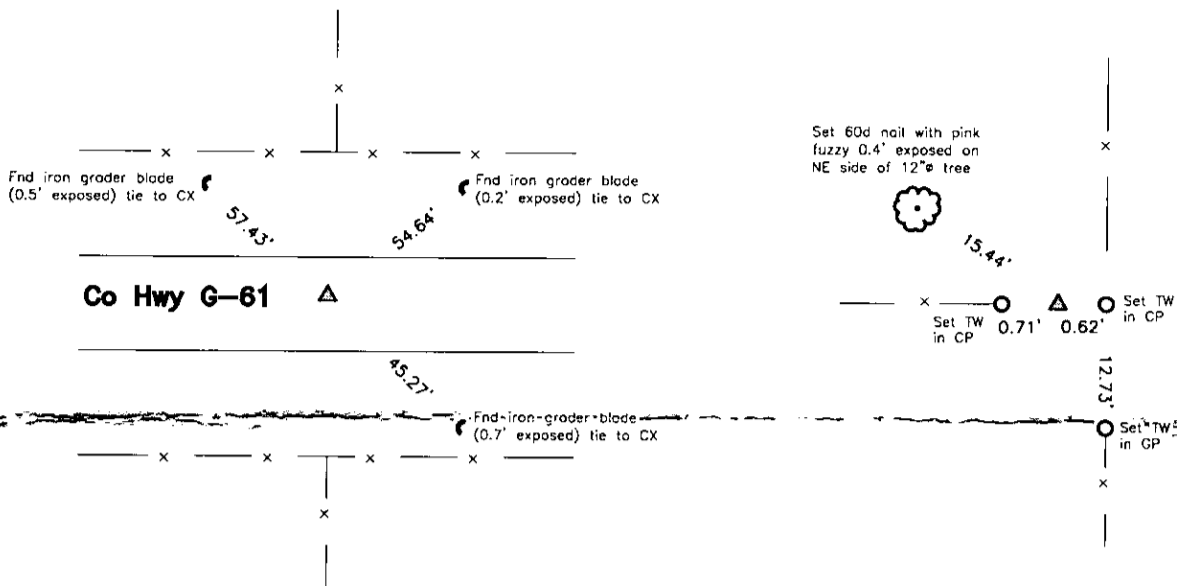
S¼ Cor. - History of Corner=1932 - Co Rec's Bk 70 Pg 139 indicates usage of corner, but does not indicate type of monumentation at corner.

Co Engr's previous and current records do not indicate that corner is monumented.

Corner Recovery = Visually searched area and found cut 'X' at 0.7'± N of centerline joint of new PCC road E-W, in-line with fence S, and 2.0'± W of fence N. Monument found is clearly Co Engr's road PI. However, PCC road makes excavation impractical, distance from this monument to SW Cor is within reason of record (see plot filed with this corner cert for measurements). In addition, the corner was used as a road PI for pavement construction in 1968, which would have determined the pavement location prior to 2005. Therefore, the road PI location as determined in 2005 should be within reason of corner location. Due to the above reasons, used cut 'X' as the correct corner. All ties are plumb distance unless indicated otherwise.

W¼ Cor. - History of Corner = No available records indicate that corner is monumented.

Corner Recovery = Visually searched area and found wooden corner post for fence W beside wooden corner post for fence N-S. Searched area 2.0'± E-W from 1.5'± N of said posts to 4.0'± S of said posts with tile probe and found nothing. Since there is no record of monumentation at this corner and since no monument can be located, set 3/4"Ø x 4.0' Alum capped iron reroad (#15745) stamped "¼ COR", "7" and "12" between said corner posts using available fenceline evidence and used it as the correct corner. Reroad is 0.5' exposed in-line with fence W and 0.6'± W of fence N-S. All ties are plumb distance unless indicated otherwise.
