**REAL ESTATE TRANSFER - GROUNDWATER HAZARD STATEMENT
TO BE COMPLETED BY TRANSFEROR**

Time of Transfer Inspection Report

1238 Pitzer Rd, Earlham 50072

DNR Time of Transfer Report System Status

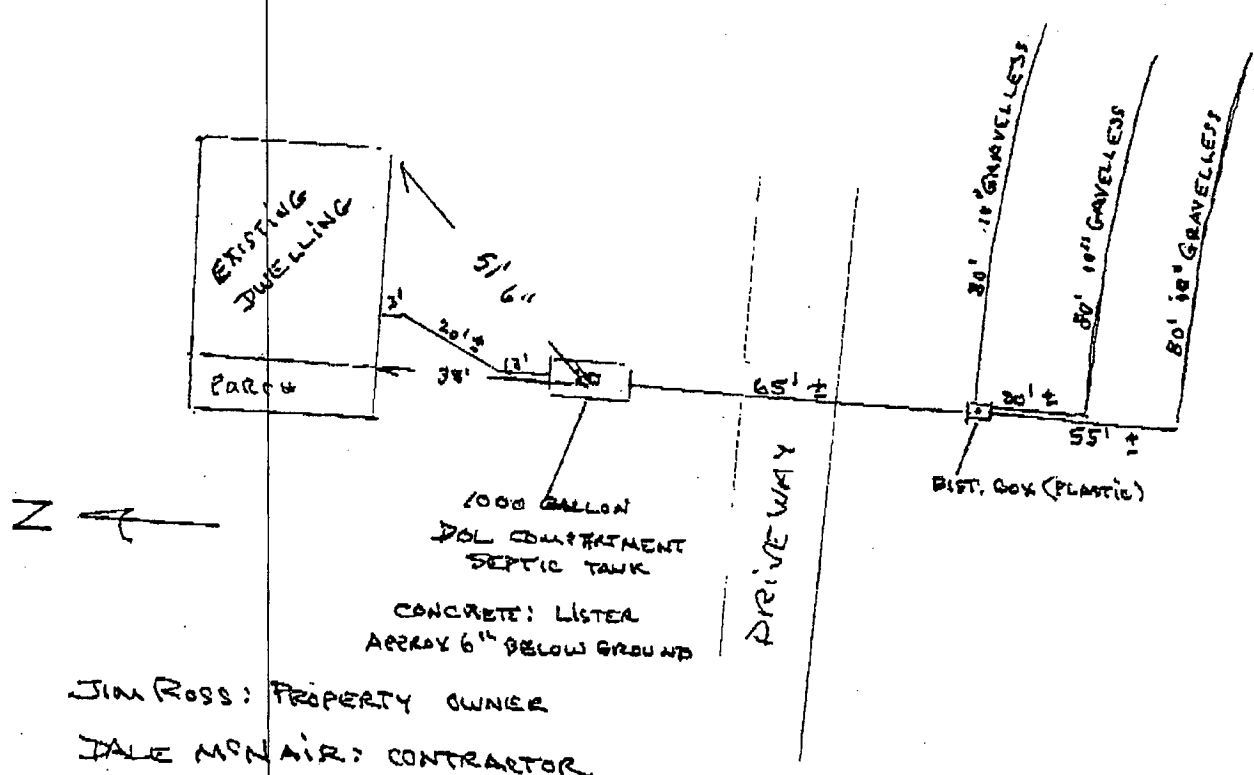
All waste water from house drains to septic system.

The septic tank is a two compartment concrete 1000 gal. tank in good condition.

The Distribution Box and all laterals were in good working condition.

BARN
