REAL ESTATE TRANSFER - GROUNDWATER HAZARD STATEMENT

Time of Transfer Inspection Report

1784 Meadow Valley Ct, Winterset Time of Transfer Inspection Report 50273

DNR Time of Transfer Report System Status

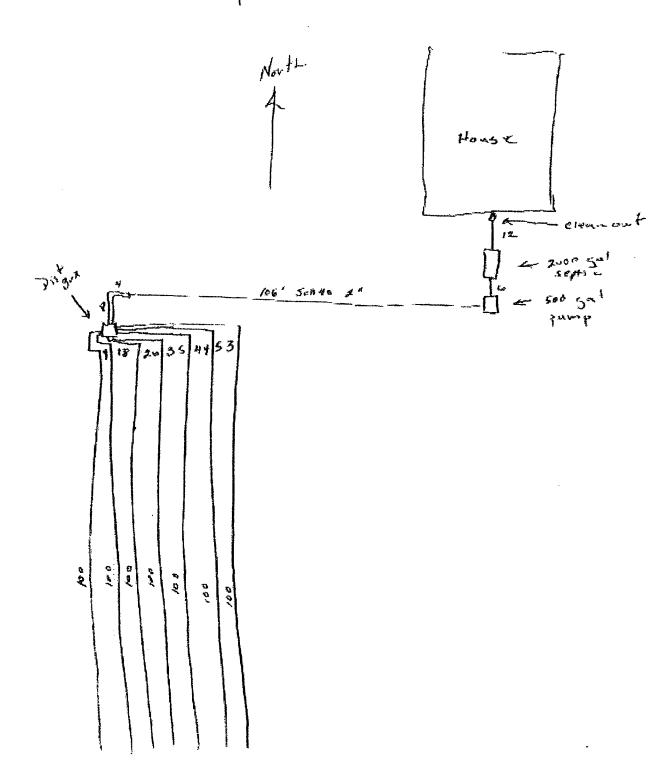
Permit # 040-07 Lot 35 Covered Bridge Estates Inspection 4/6/07
1784 Meadow Valley Ct

Address: 1784 Meaclaw Valley Ch Winkerset Is 50273 Date: 11/22/11
Comments: Technician de Mulu
All Wash Water In Home Brains To Septic System,
Septic Tank Is & Consactment with Efficient Filter
In Good Condition, Pump Pit on System Is Gorcete
In Good Conclition, Lift Amp Operated Well At
Inspection And Alarm Is In Working Order, Dish Box
J. Plastic In Good Condition, Laterial Field Proped
Wet But Took Water Well At Time of Inspection And
Here Is No Surfacing of Laterial Field.
* This Is Not A Guaratee, This States The Condition &
of Septic System At Time of Inspection
<u> </u>

DIAGRAM OF SYSTEM
