**REAL ESTATE TRANSFER - GROUNDWATER HAZARD STATEMENT**

### Time of Transfer Inspection Report

Site Address/County: 1799 200th Street Winterset, IA 50273

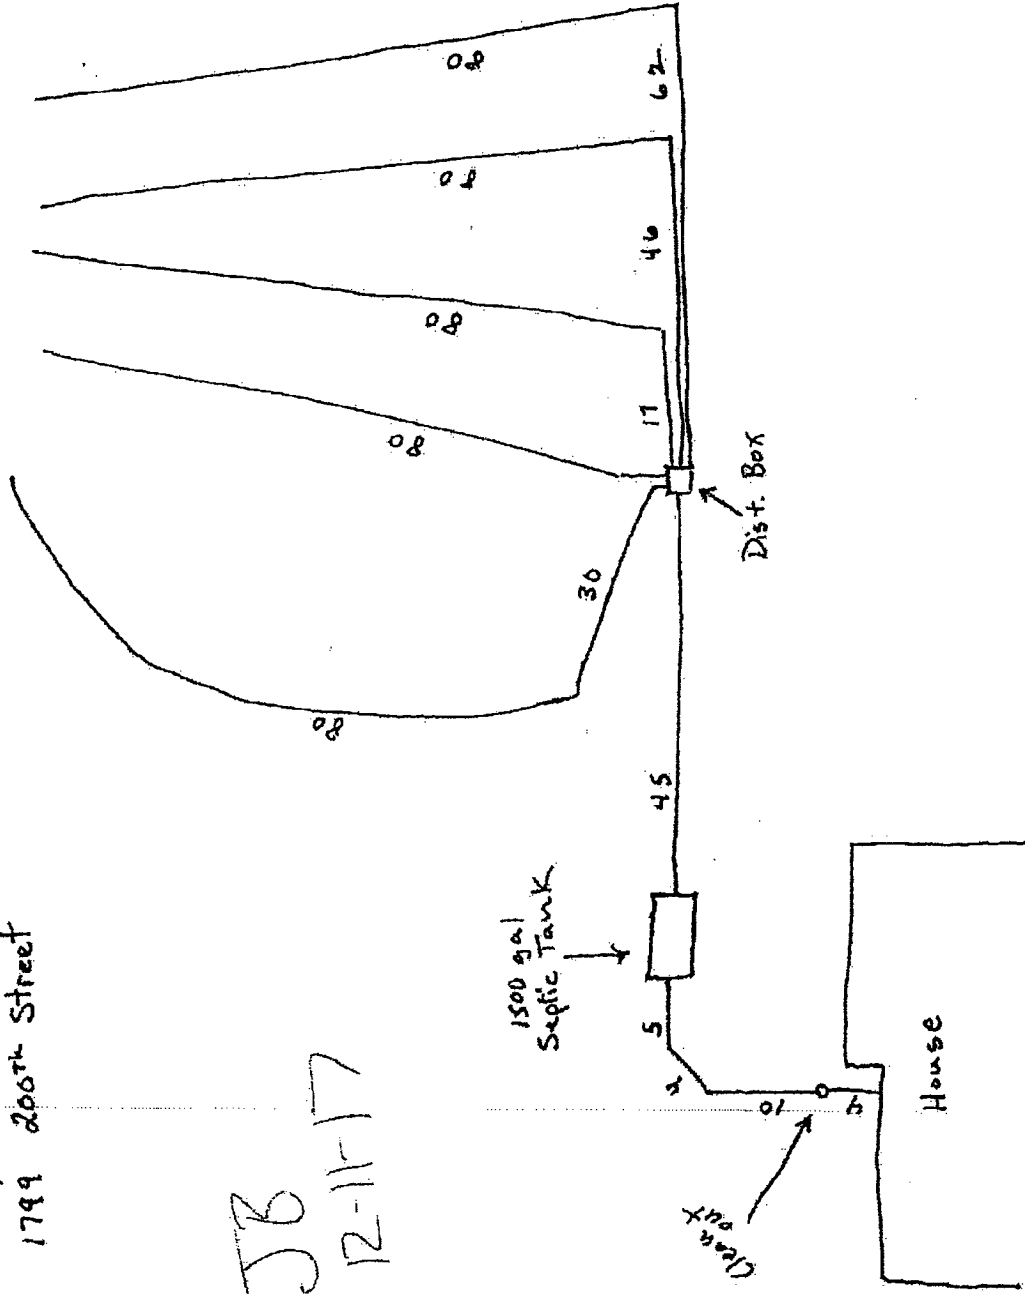
Permit # 024-13  
Inspection 11/15/13  
1799 200th Street

Distribution system: Distribution box Plastic Outlets used 5 Condition: Good

Length of absorption fields: 5 @ 80' Determined by: map, Probe

Condition of fields: Good, dry Determined by: hydraulic test

The System was working properly on the day of inspection. When the hydraulic test was performed it was discovered that the lateral line farthest east was not taking any water. The other four lines handled the hydraulic test and took water the entire test. The secondary treatment field was dry and looked good on the day of inspection.
