UNITED STATES PUBLIC LAND SURVEY CORNER CERTIFICATE OF

Land Survey Monuments situated in Section 26, Township 89 North, Range 6 West of the Fifth Principal Meridian, Delaware County, Iowa.

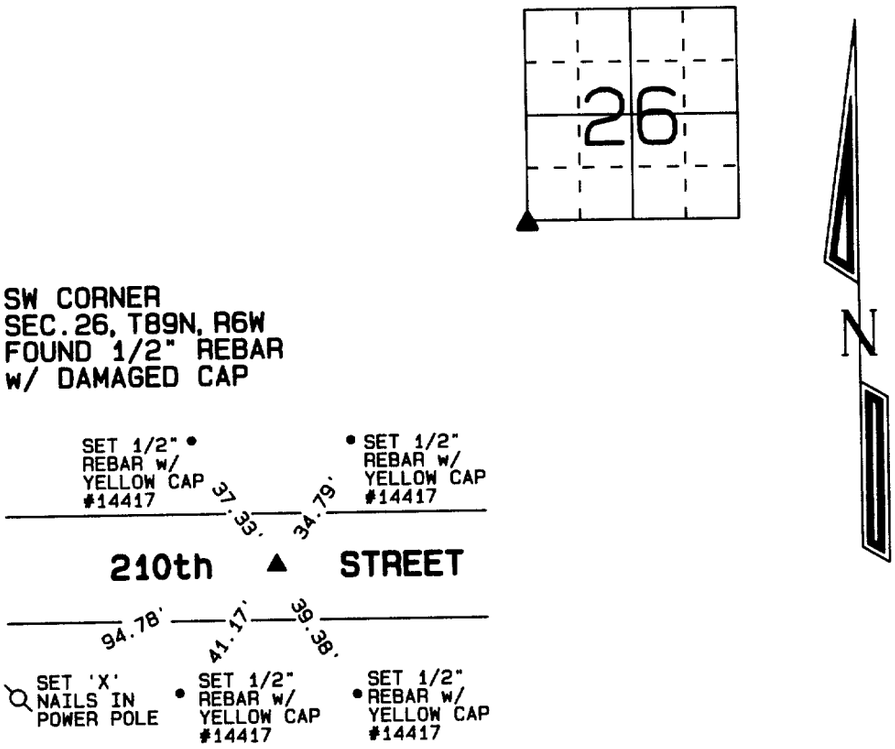
PLAN - VIEW

Monument Description and Remarks: A 1/2" REBAR WITH A DAMAGED CAP WAS FOUND AT THE SW CORNER OF SECTION 26 AS ILLUSTRATED IN SECTION CORNER CERTIFICATE FILED IN BOOK 2, PAGE 28. THE CORNER WAS RETIED DUE TO REMOVAL OF THE FENCE. THE 1/2" REBAR WAS TIED AND USED AS THE CORNER.
