REAL ESTATE TRANSFER - GROUNDWATER HAZARD STATEMENT
TO BE COMPLETED BY TRANSFEROR

Address of Property Transferred:
1895 120th Avenue, Manchester, Iowa 52057
Number and Street or RR | City, Town, or P.O. | State | Zip

Time of Transfer Inspection Report (DNR Form 542-0191)

Harter Custom Pumping, Inc & Septic Service

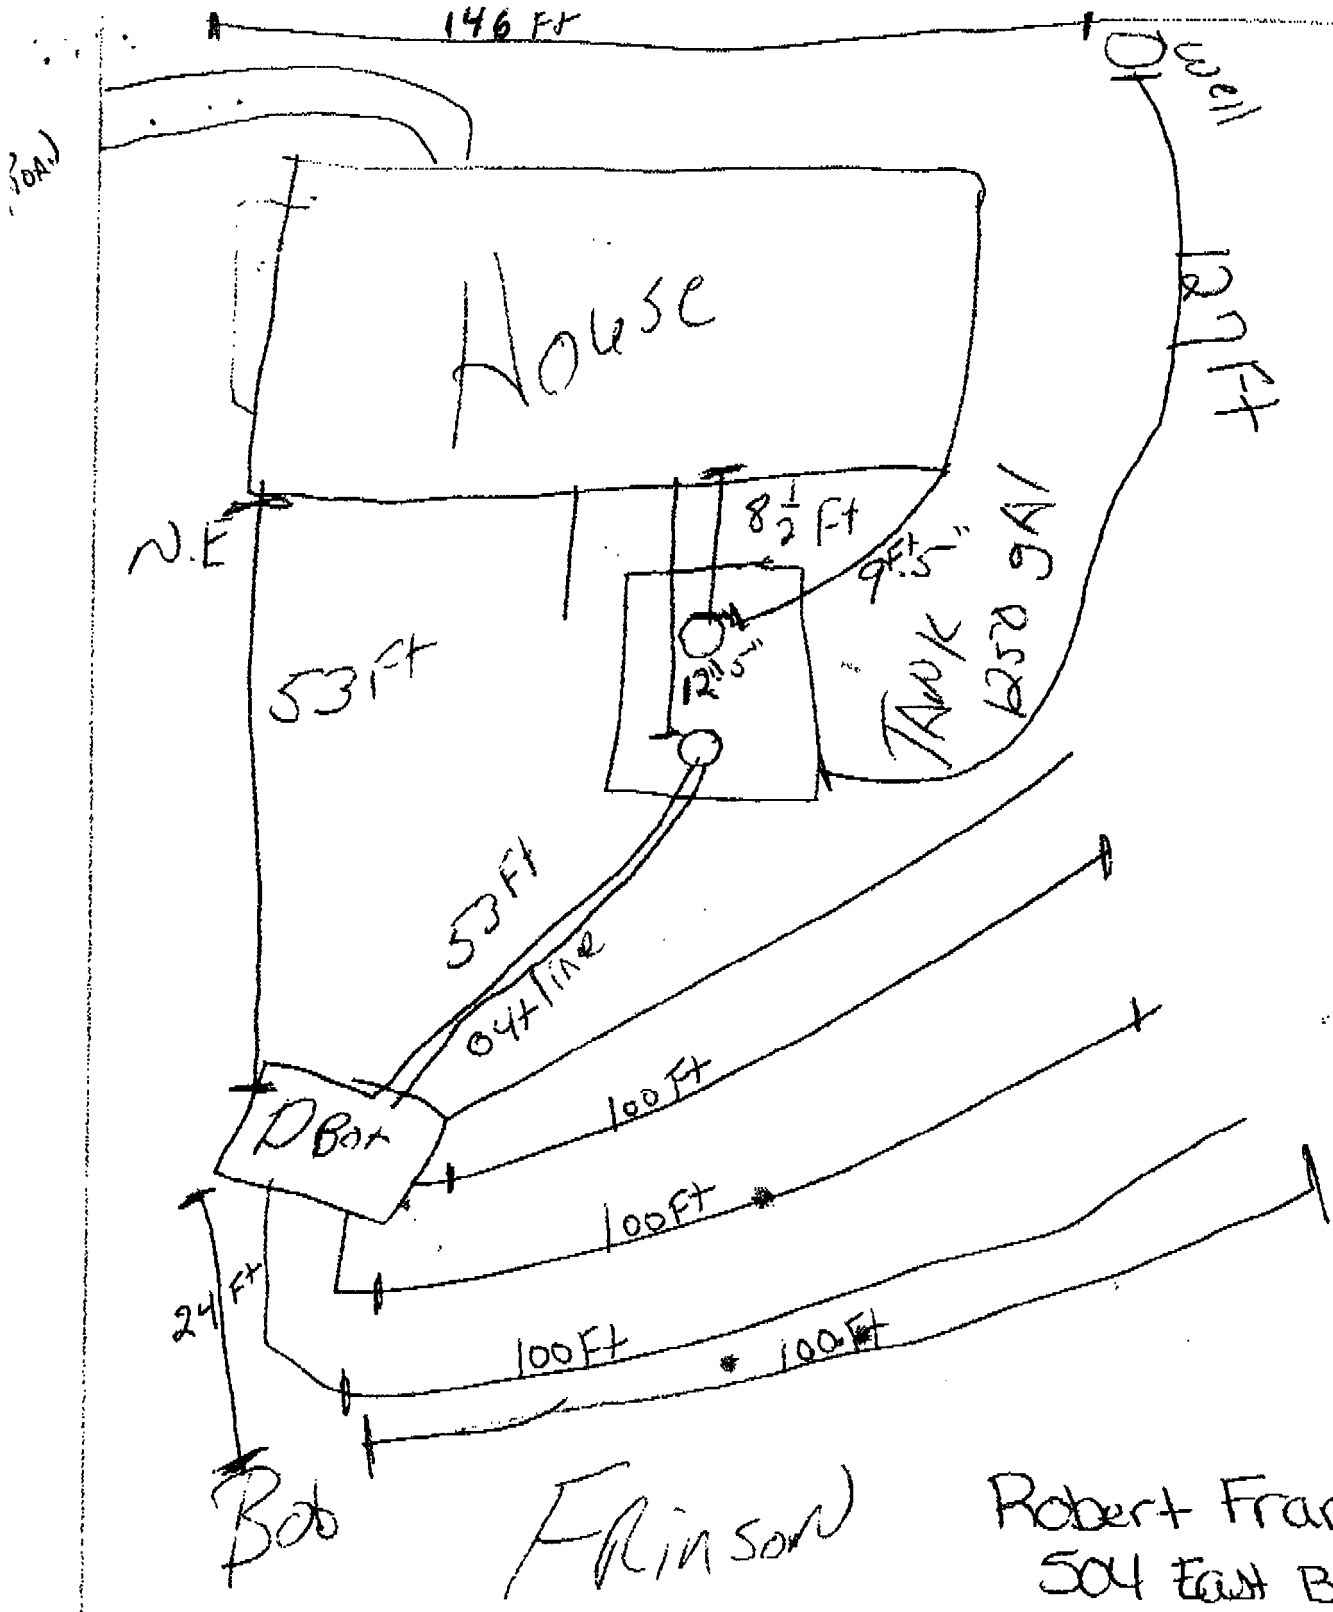
Location of the system: East West (North) South
Was Water run into the system for 30 minutes? (Yes) No
Does the septic tank have a visible riser? (Yes) No
Estimated size of tank 1250 Gallons *Basis for estimate*
What is the separation between well and septic? 120 Ft
Does the separation of the well and septic meet local requirements? (Yes) No N/A

Any evidence of malfunction (No) Yes (Please check all applicable observed conditions)
___ Wet Areas ___ Unusual green/lush vegetation
___ Liquid Discharges to surface ___ Discharge pipe of unknown origin
___ Localized surface settling ___ Other (Describe below)
