REAL ESTATE TRANSFER - GROUNDWATER HAZARD STATEMENT

Homeowners: Svoboda, Diana M
20741 257th St
Manchester, IA

Time of Transfer Inspection Report

Time of Transfer Inspection Report (DNR Form 542-0191)

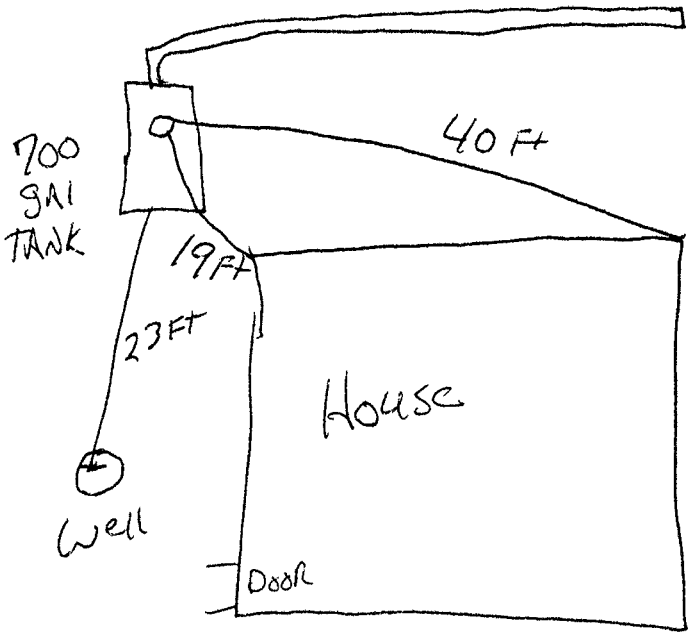
TANK is 19Ft S W of House
TANK is 40Ft NW of House
Well is 23Ft From TANK
