REAL ESTATE TRANSFER - GROUNDWATER HAZARD STATEMENT

3281 Vine Road, Dyersville, IA 52040

Time of Transfer Inspection Report (DNR Form 542-0191)

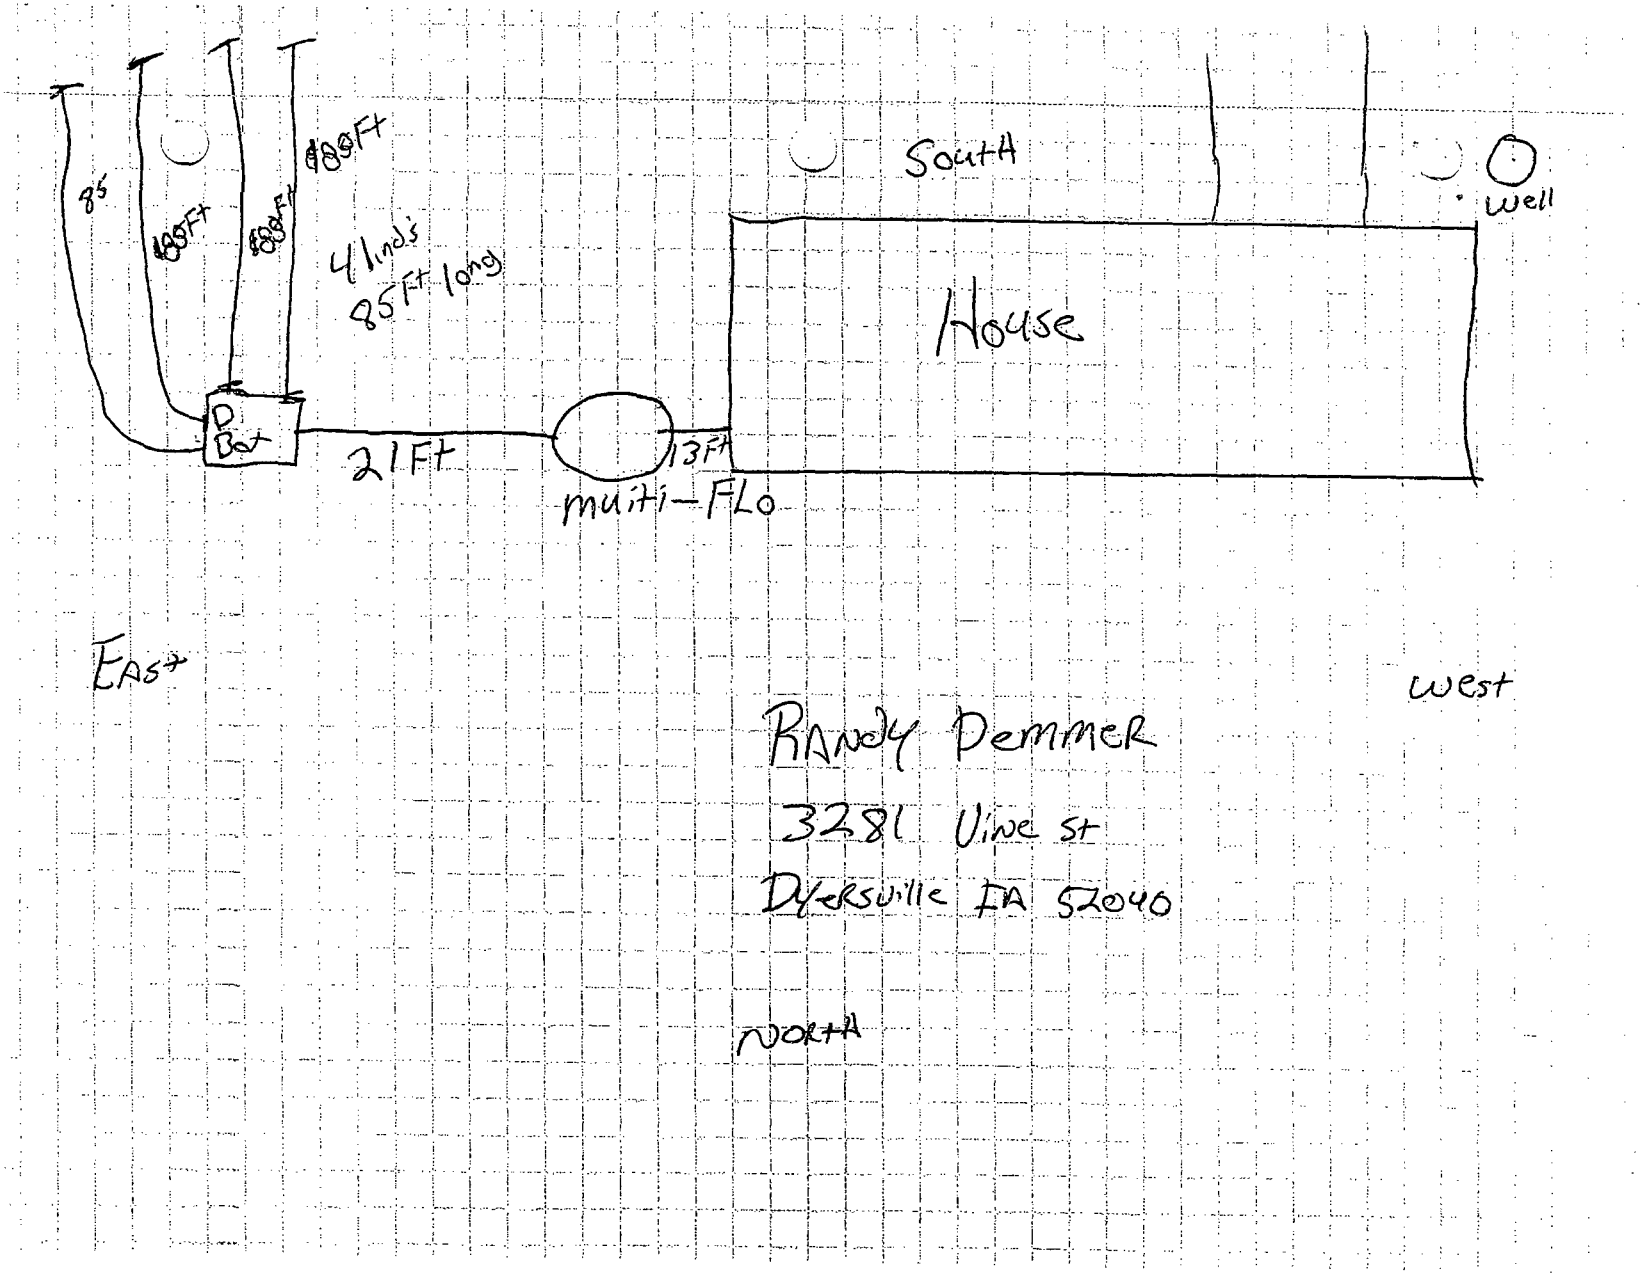
Report system status All working

85
85Ft
85Ft
85Ft
4 Inds
85Ft long
South
Well
House
D Box
21Ft
13Ft
multi-FLO
East
West
RANDY DEMMER
3281 Vine St
Dyersville IA 52040
north
