REAL ESTATE TRANSFER - GROUNDWATER HAZARD STATEMENT

Time of Transfer Inspection Report (DNR Form 542-0191)

Harter Custom Pumping, Inc & Septic Service

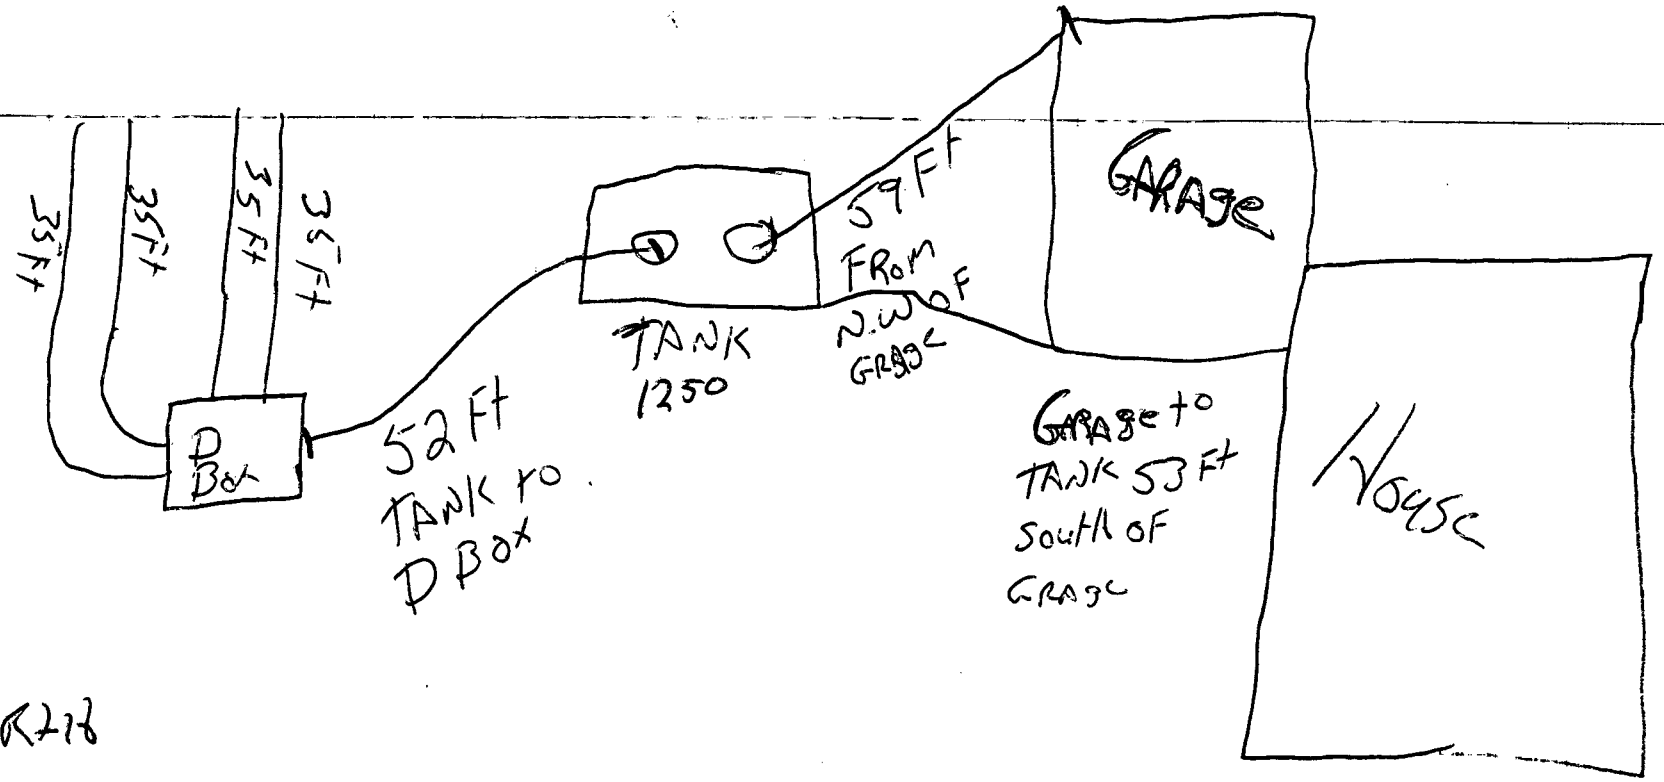
Report system status ALL in good working condition.

Location of the system: East West (North) South
Was Water run into the system for 30 minutes? (Yes) No
Does the septic tank have a visible riser? (Yes) No
Estimated size of tank 1250 Gallons *Basis for estimate*
What is the separation between well and septic? yes 90 FT
Does the separation of the well and septic meet local requirements? (Yes) No N/A

Any evidence of malfunction (No) Yes (Please check all applicable observed conditions)
___ Wet Areas ___ Unusual green/lush vegetation
___ Liquid Discharges to surface ___ Discharge pipe of unknown origin
___ Localized surface settling ___ Other (Describe below)

KEEP TANK PUMP EVER 3-5 YEARS
