REAL ESTATE TRANSFER - GROUNDWATER HAZARD STATEMENT

Address of Property Transferred:
20097 Stone Briar Ln., Dyersville, IA 52040

Time of Transfer Inspection Report (DNR Form 542-0191)

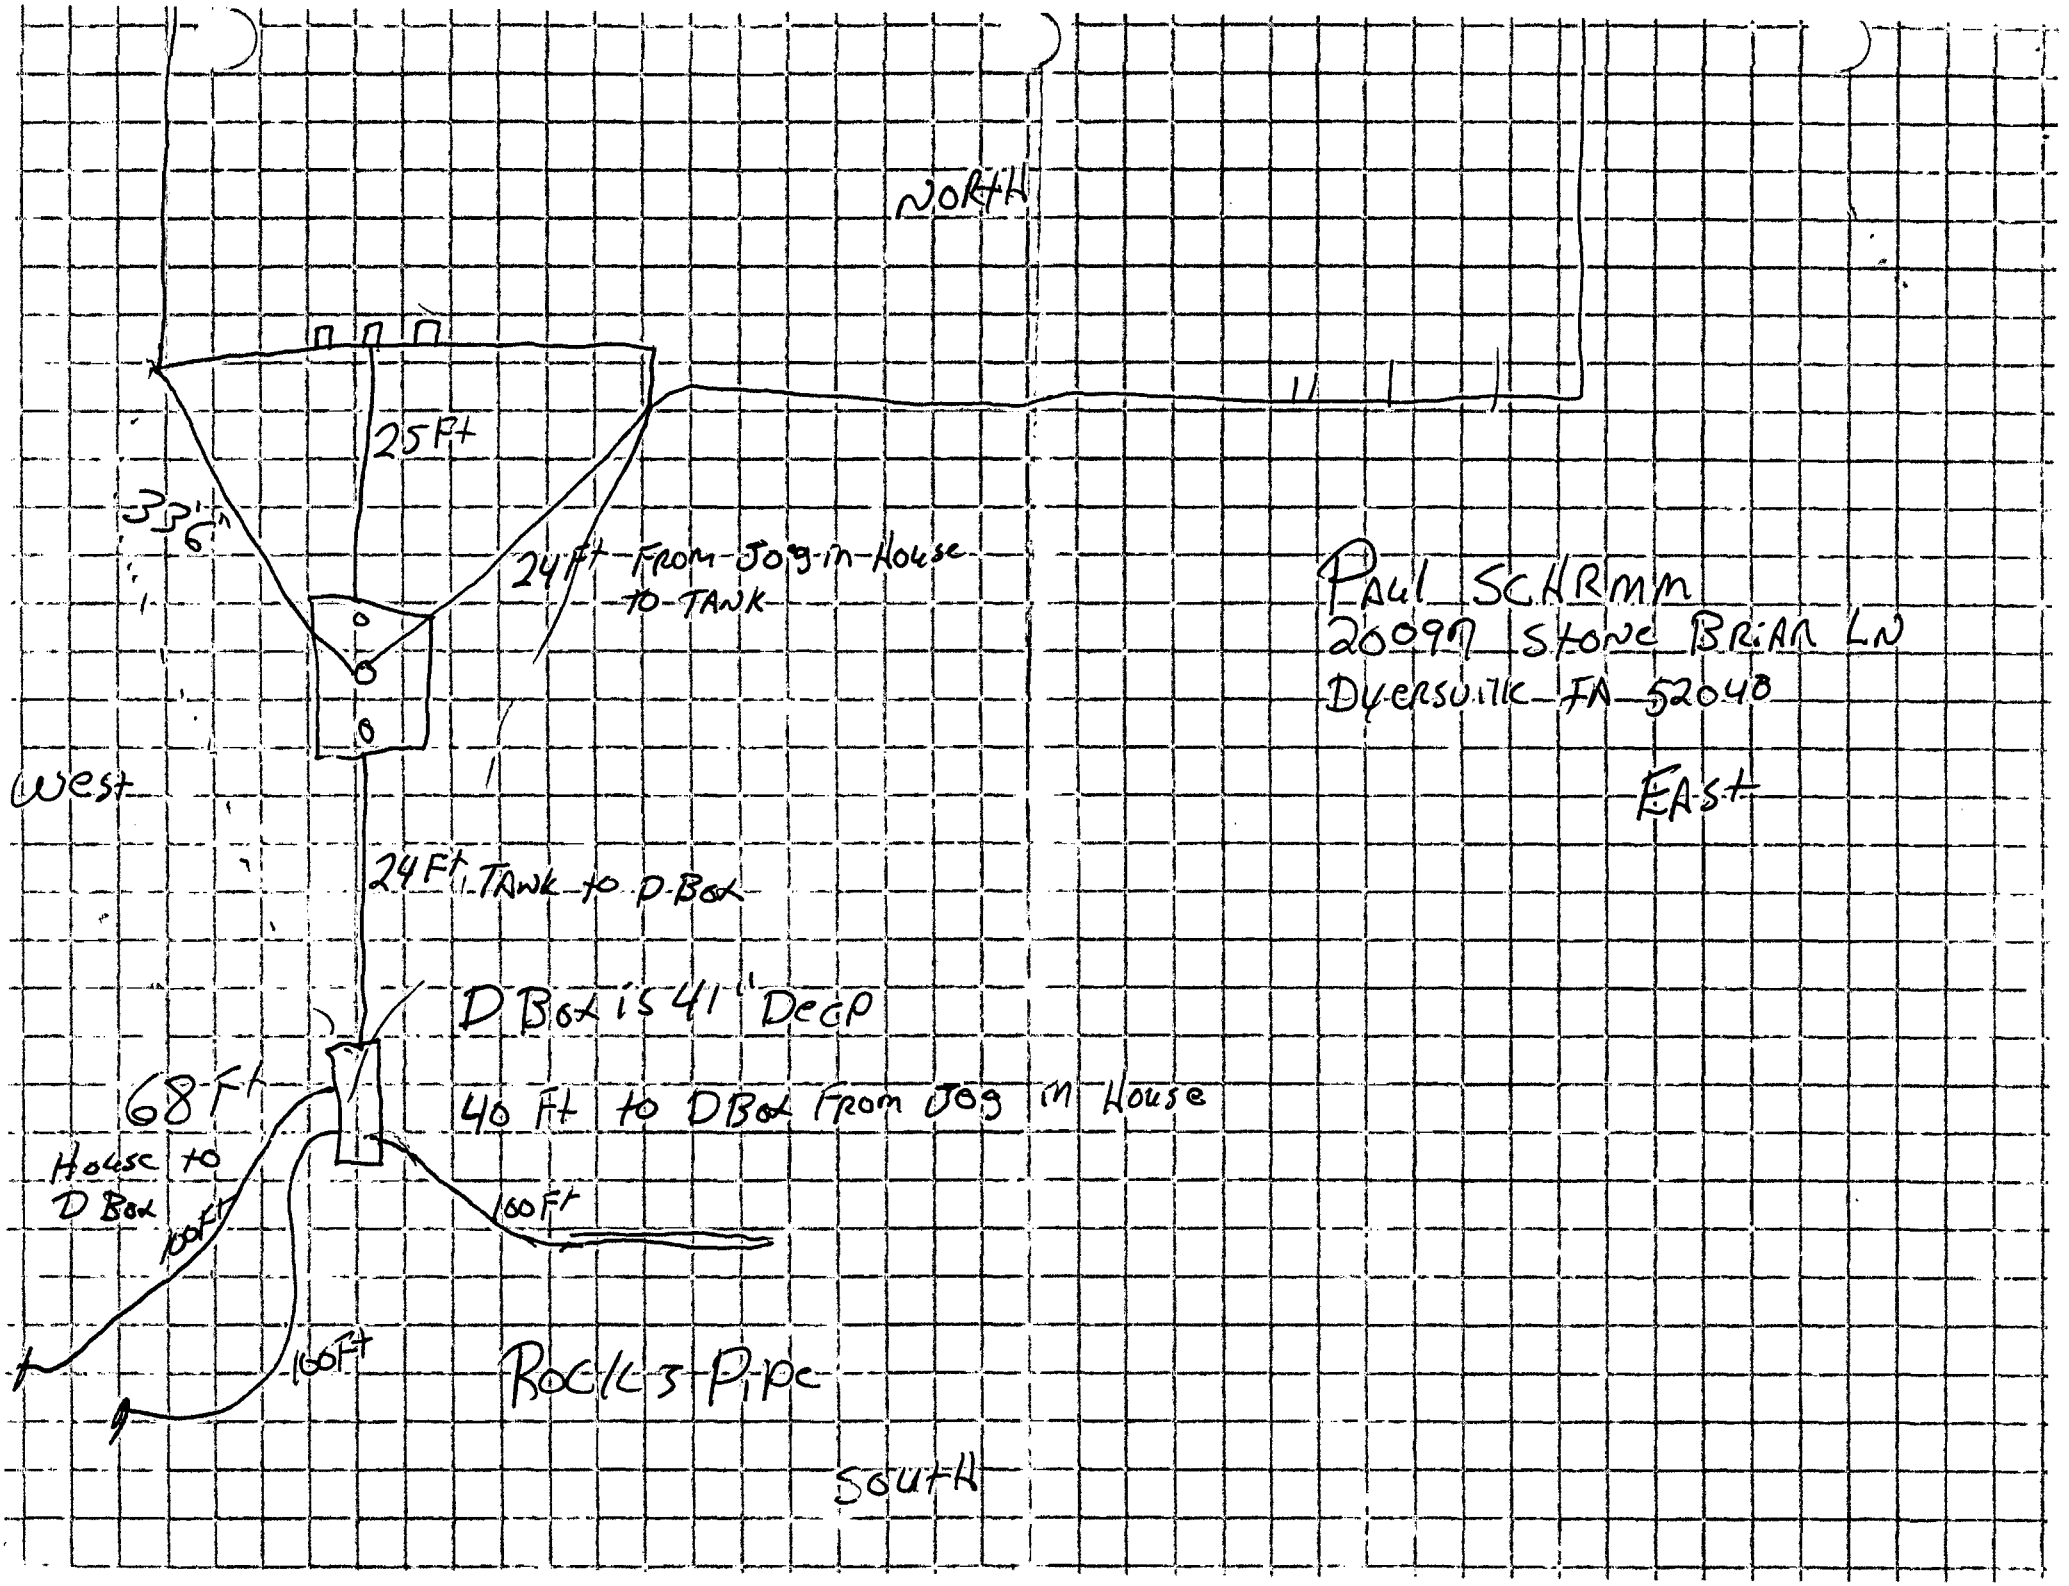
North
25Ft
33'6"
24Ft From Jog in House to TANK
Paul SCHRMN
20097 Stone Briar LN
Dyersville IA 52040
West
East
24Ft TANK to D Box
D Box is 41' Deep
68Ft
40 Ft to D Box From Jog in House
House to D Box
100Ft
100Ft
160Ft
Rocks Pipe
South
