REAL ESTATE TRANSFER - GROUNDWATER HAZARD STATEMENT
TO BE COMPLETED BY TRANSFEROR

Time of Transfer Inspection Report (DNR Form 542-0191)

Harter Custom Pumping, Inc & Septic Service

Inspection Co: Robb Harter
3031 160 St Dyersville
Date of Inspection: 6-14-2011

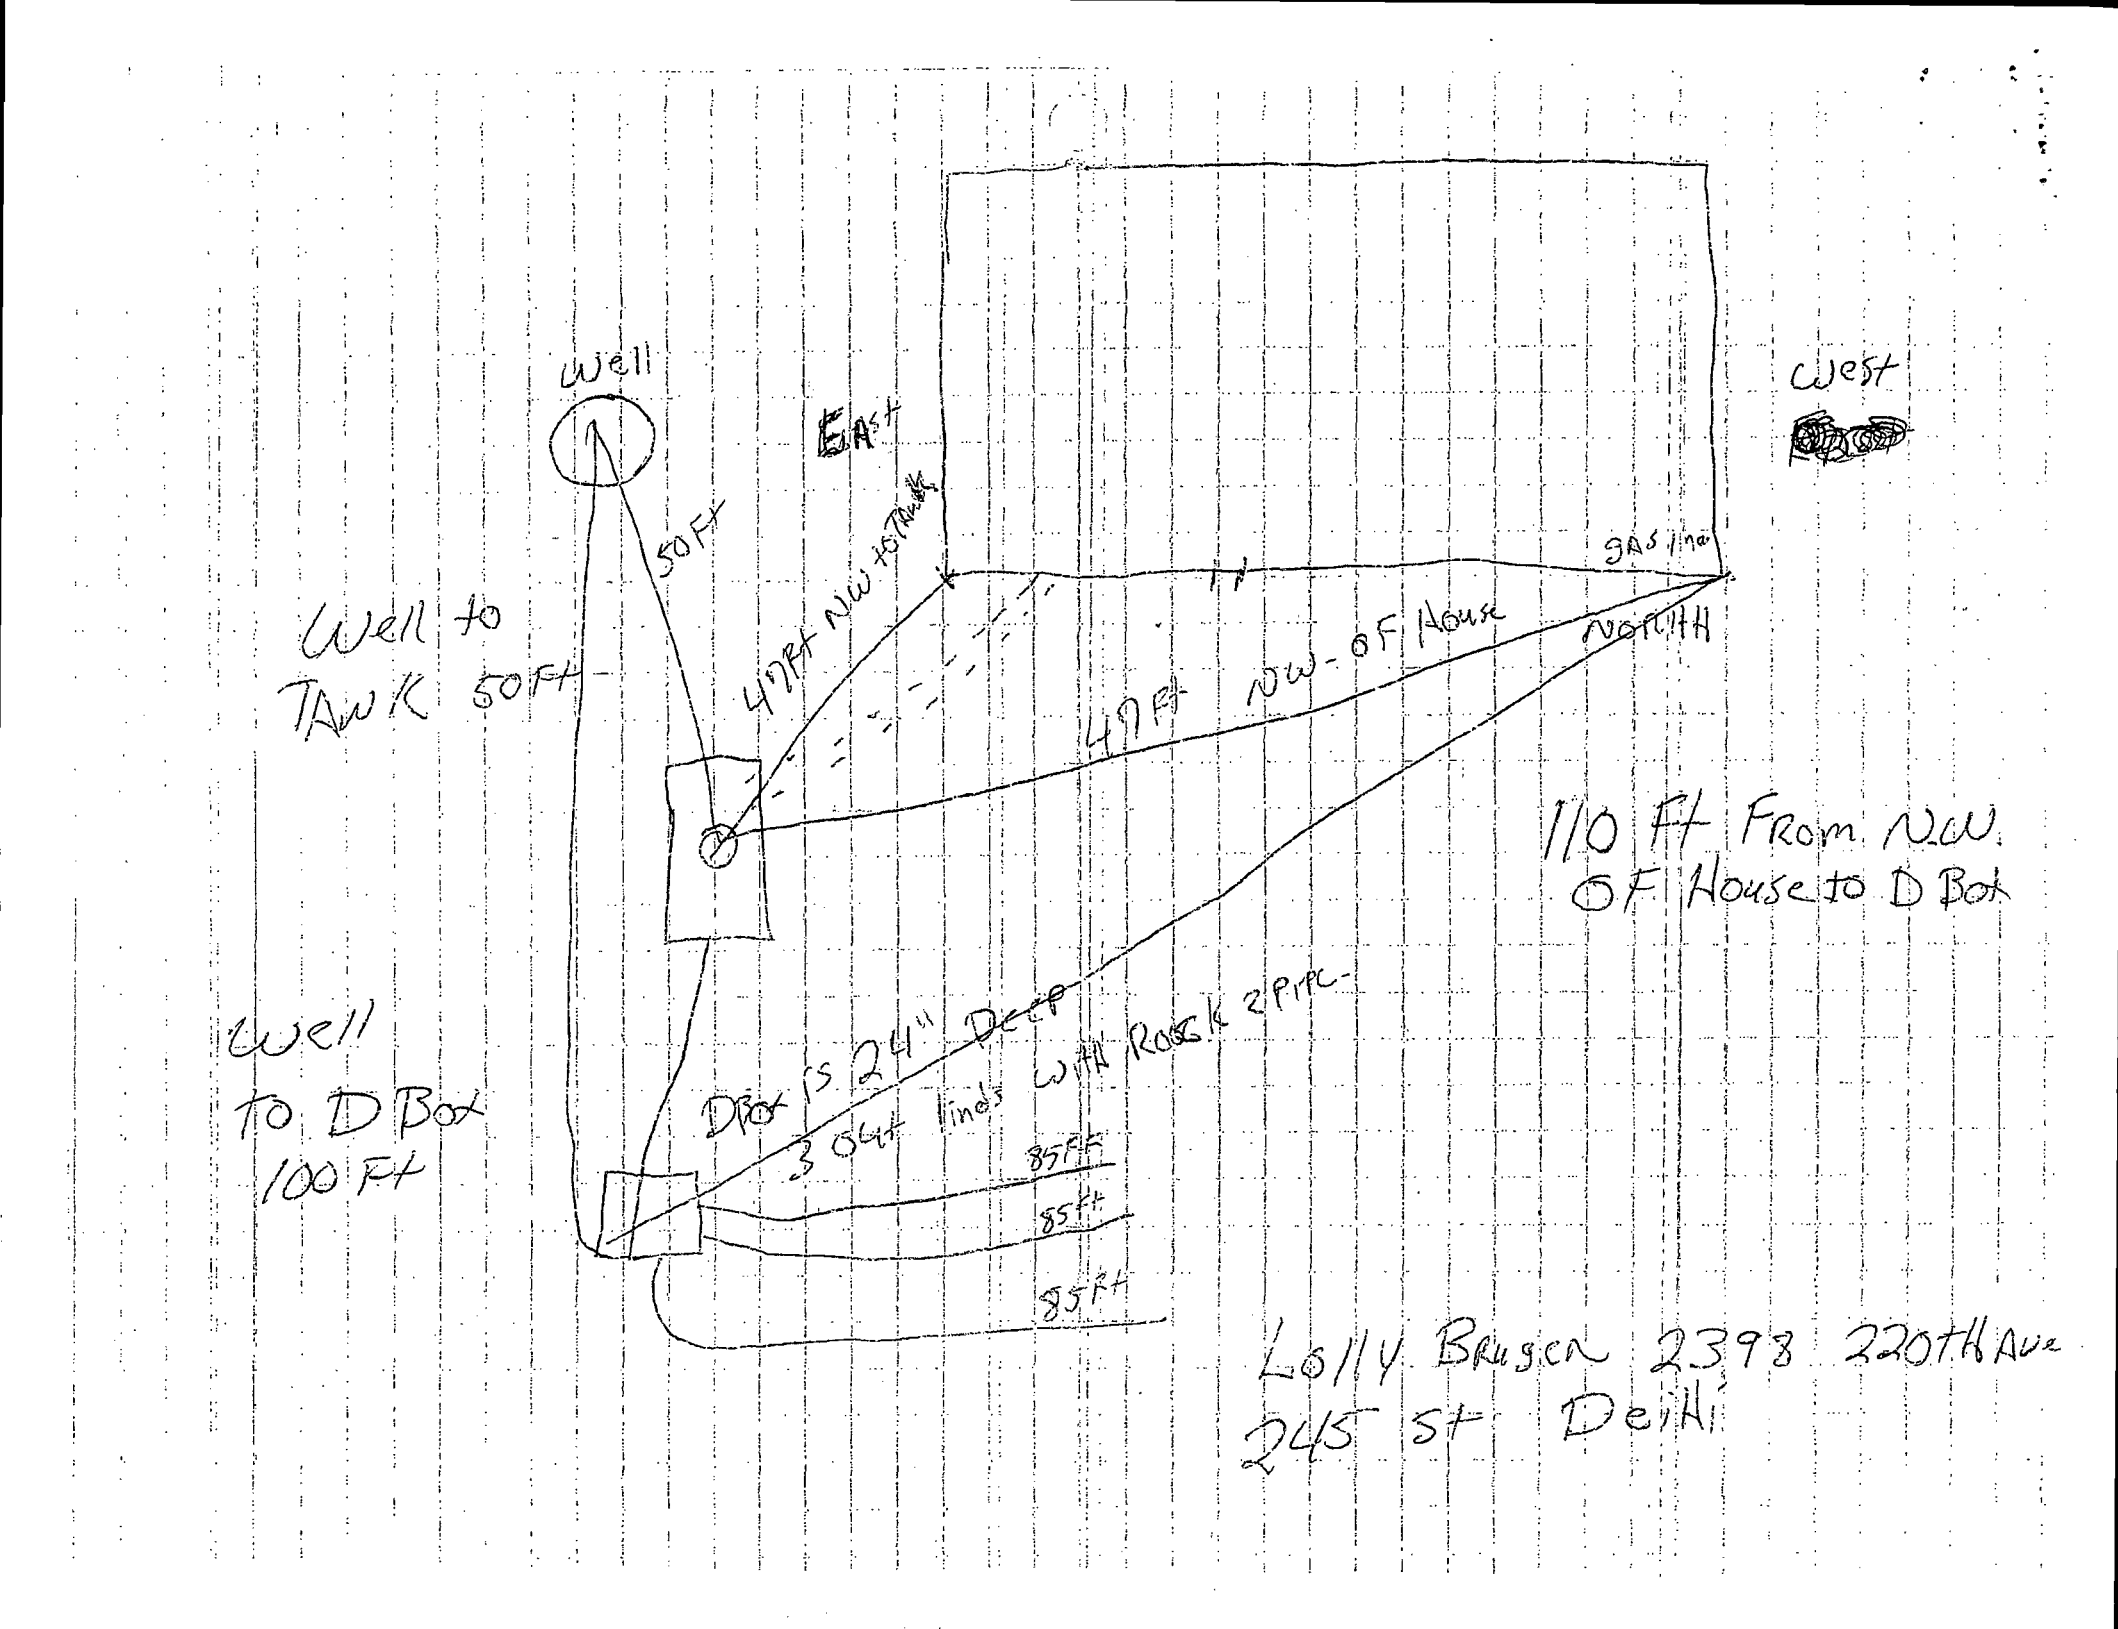
Septic Tank

Any evidence of malfunction (No) Yes (Please check all applicable observed conditions)
___ Wet Areas ___ Unusual green/lush vegetation
___ Liquid Discharges to surface ___ Discharge pipe of unknown origin
___ Localized surface settling ___ Other (Describe below)

Septic tank material X Concrete ___ Fiberglass ___ Other
Liquid Level in tank X Normal ___ Below Normal ___ Above Normal
Access opening in tank ___ One ___ Two X Three ___ None
Number of risers X One ___ Two ___ Three ___ None
Condition of baffles and or sanitary tees:
Inlet baffle or "T" X Present and functional ___ Not functional ___ None present ___ Not Visible
Outlet baffle or "T" X Present and functional ___ Not functional ___ None present ___ Not Visible
Tank was pumped X Yes ___ No (if no please explain below
Is system adequately sized for # of Bedrooms X Yes ___ No # of Bedrooms: ___
Is system adequately sized for # of Bathrooms X Yes ___ No # of Bathrooms: ___
System working Properly X Yes ___ No (if no please explain below)

Tank need to be pump each 3-5 years.
