REAL ESTATE TRANSFER - GROUNDWATER HAZARD STATEMENT

Homeowners: Dale Cooper
22109 181st Ave
Manchester, Ia
52057

Time of Transfer Inspection Report (DNR Form 542-0191)

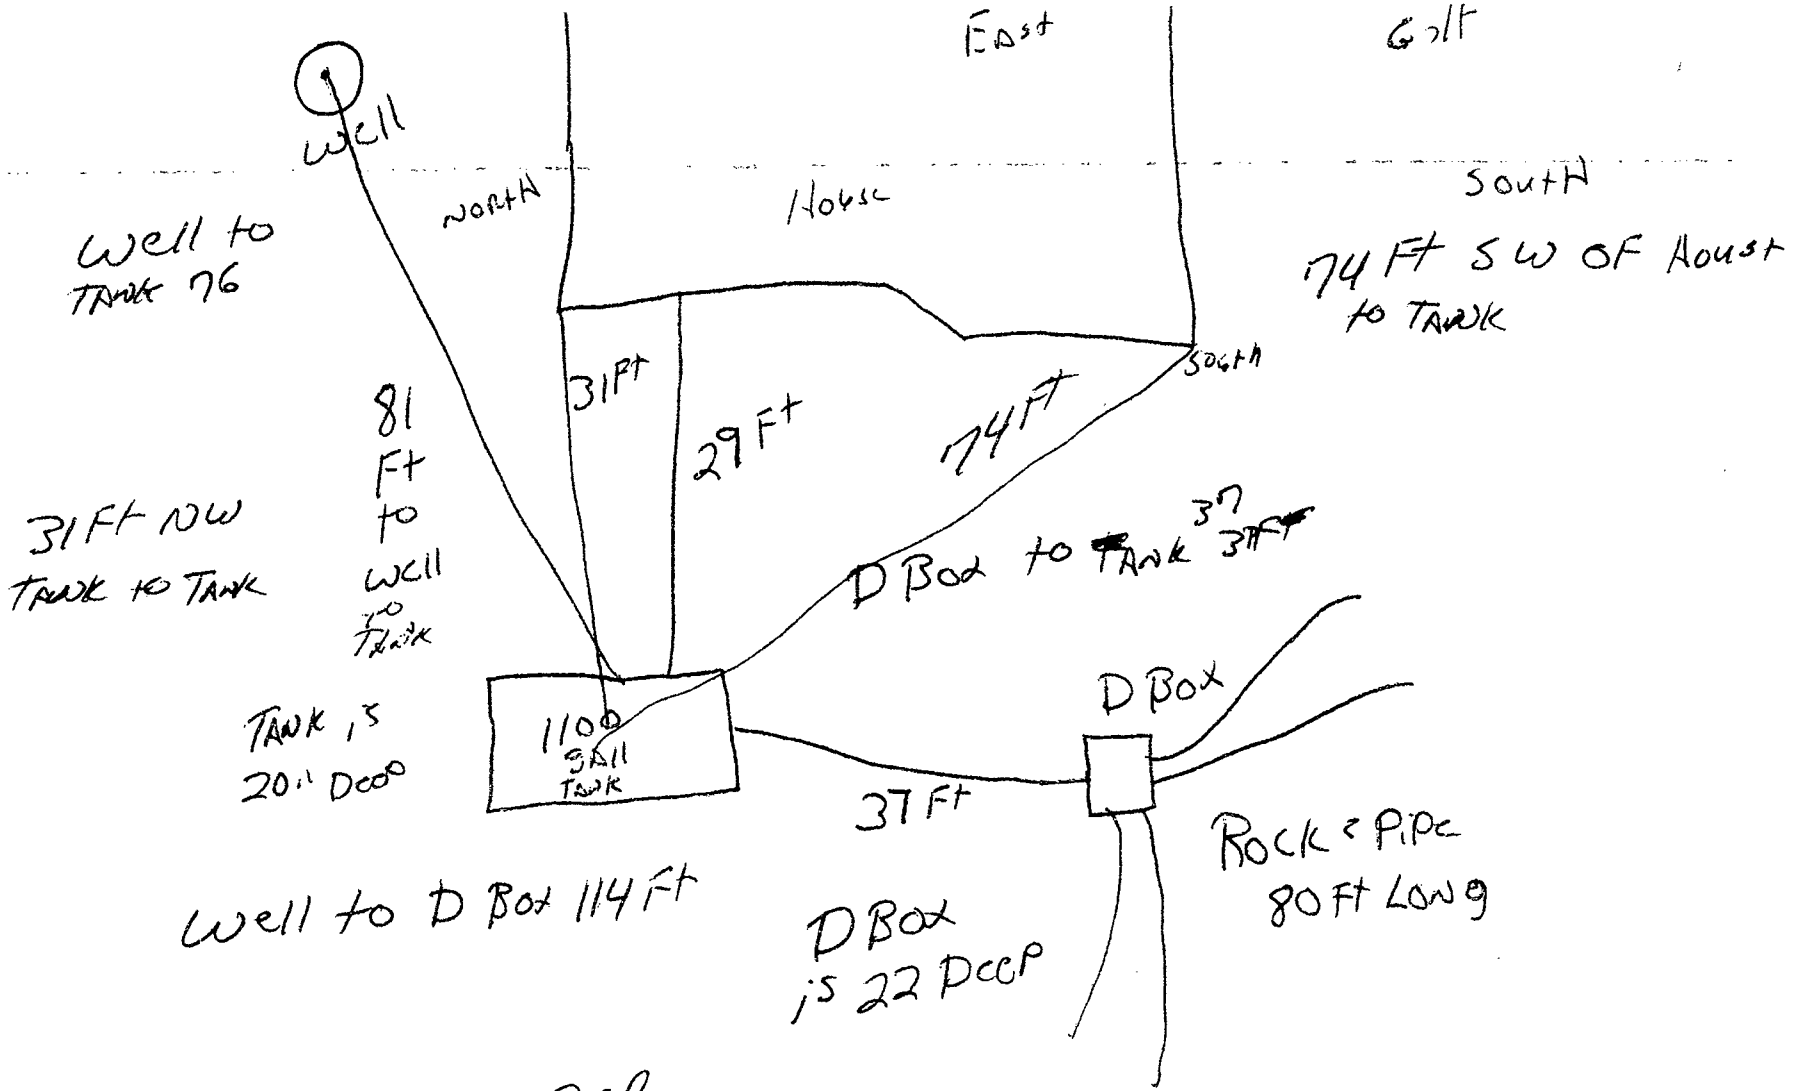
DAlc COOPER
22109 181st Ave
MANCHESTER IA
52057

22109 181st Ave
MANCHESTER IA 52057
