REAL ESTATE TRANSFER - GROUNDWATER HAZARD STATEMENT

Address of Property Transferred:
2939 197th St, Earlville, IA 52041

Time of Transfer Inspection Report (DNR Form 542-0191)

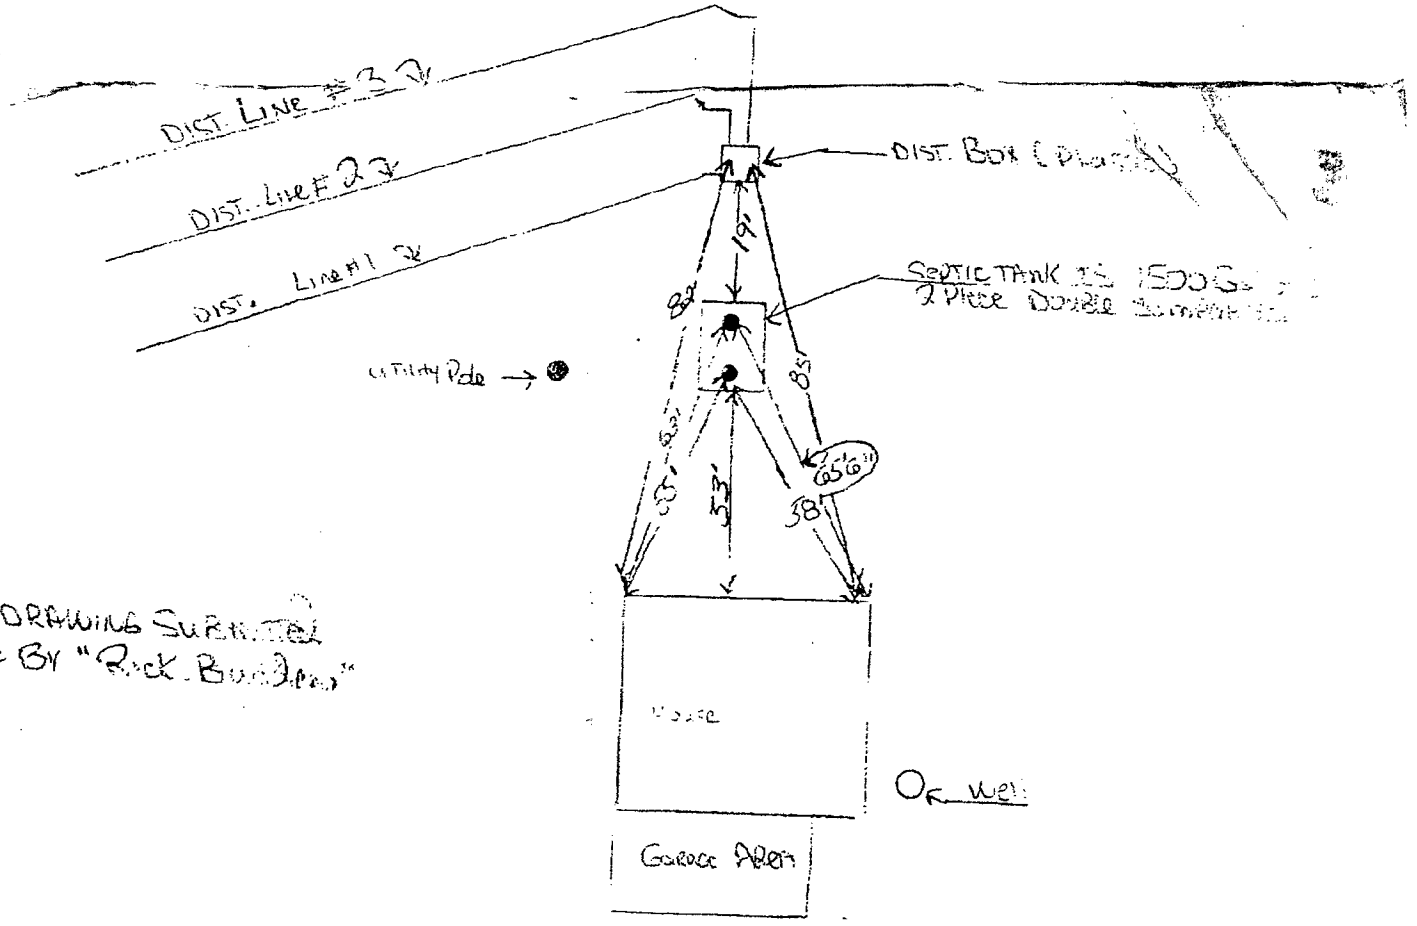
Owner's Sadie Deutmeyer / Check Book #1161
INSTALLED 5/17/2002 BY %
Builder PLBG Service LLC

DIST LINES ARE ALL 100 FT LONG (INFILTRATOR MATERIAL)
LINE #1 has 20 INCHES OF COVER
LINE #2 has 17 INCHES OF COVER — ALL LINES ARE SPACED 9 FT APART
LINE #3 has 14 INCHES OF COVER
DIST. BOX HAS A 4" MARTIN [illegible] LOCATION BROUGHT TO SURFACE
SEPTIC LIDS ARE AT GRADE
