REAL ESTATE TRANSFER - GROUNDWATER HAZARD STATEMENT

Septic Inspection
Roger Erickson Property
18222 224th St.
Manchester, IA 52057

Time of Transfer Inspection Report (DNR Form 542-0191)

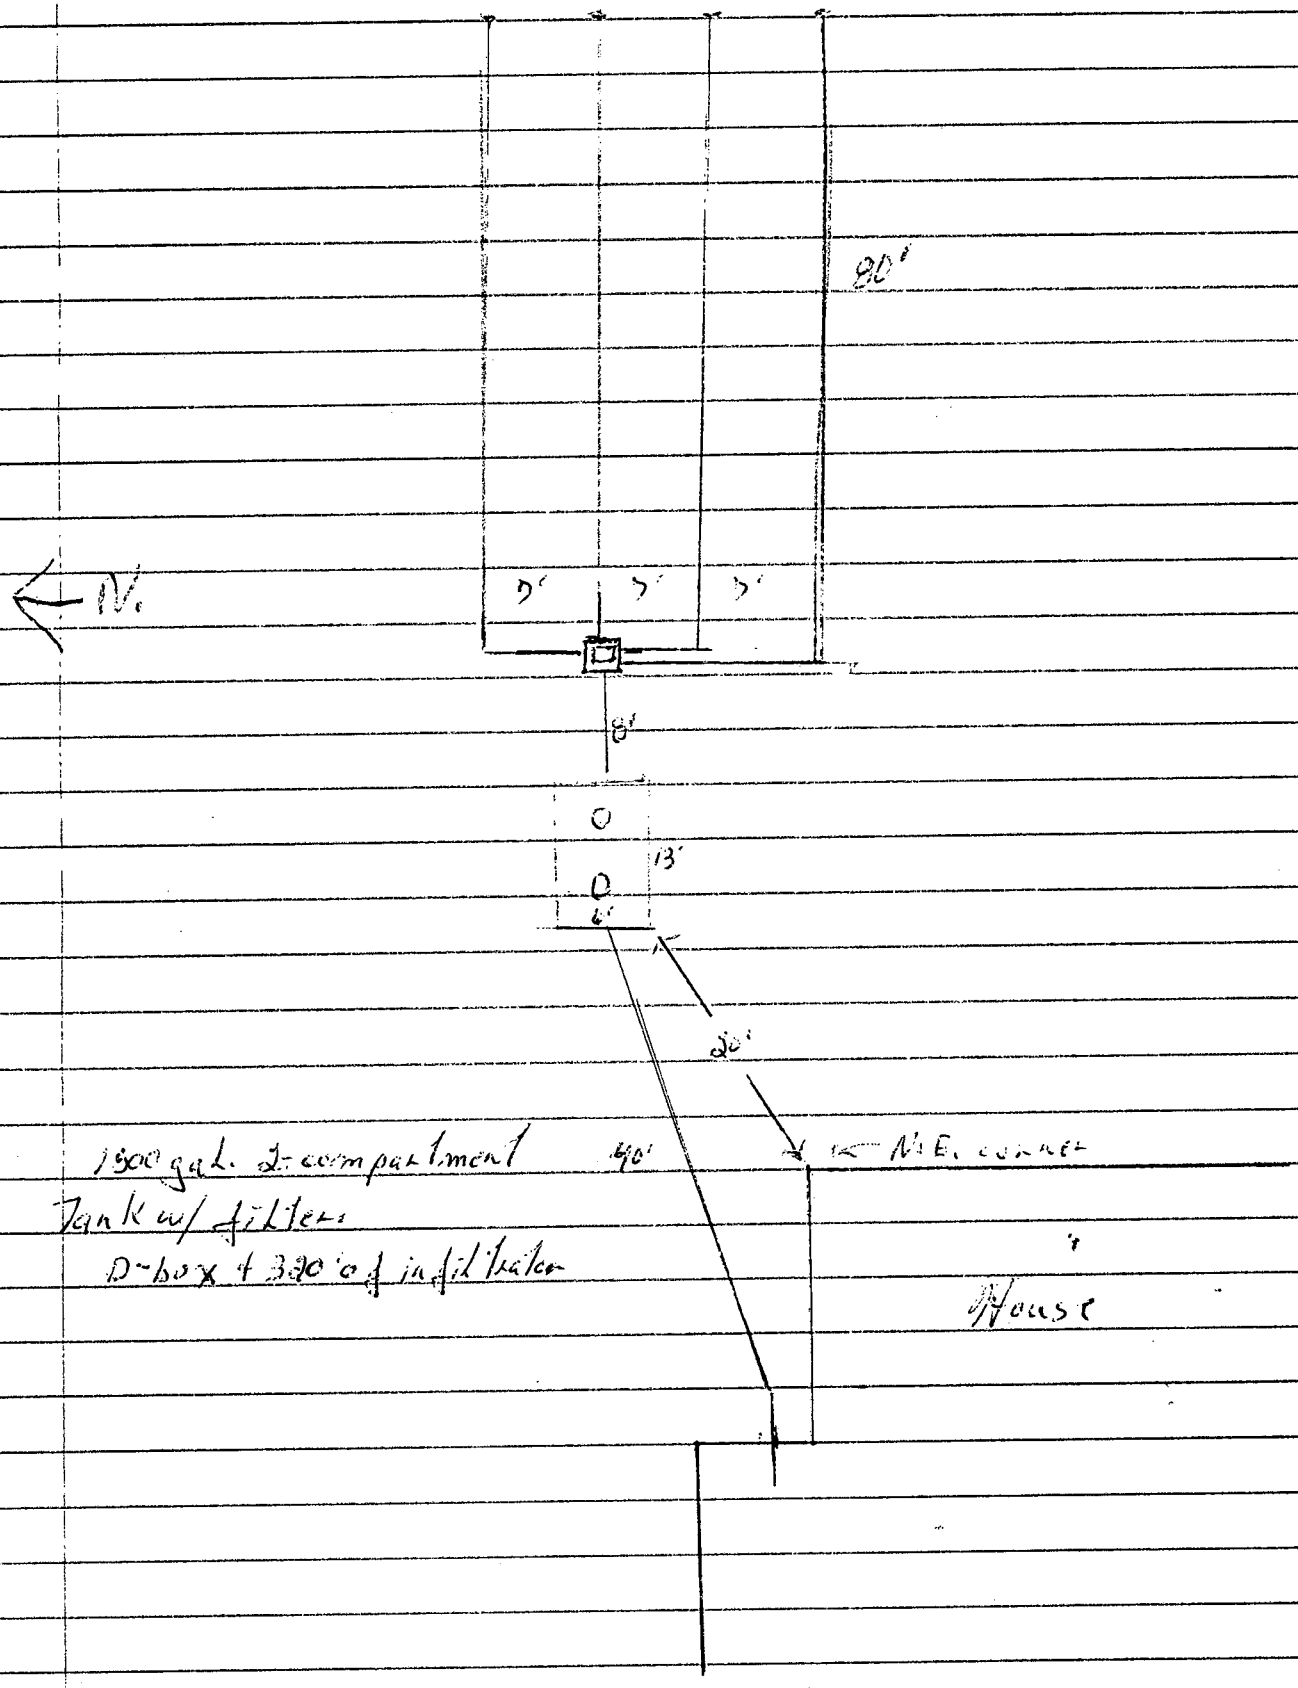
1500 gal. 2-compartment Tank w/ filters
D-box + 330 sq ft infiltrator
