REAL ESTATE TRANSFER - GROUNDWATER HAZARD STATEMENT

Septic Inspection
Carolyn Boll
412 Woodview Dr.
Dundee, IA 52038

Time of Transfer Inspection Report (DNR Form 542-0191)

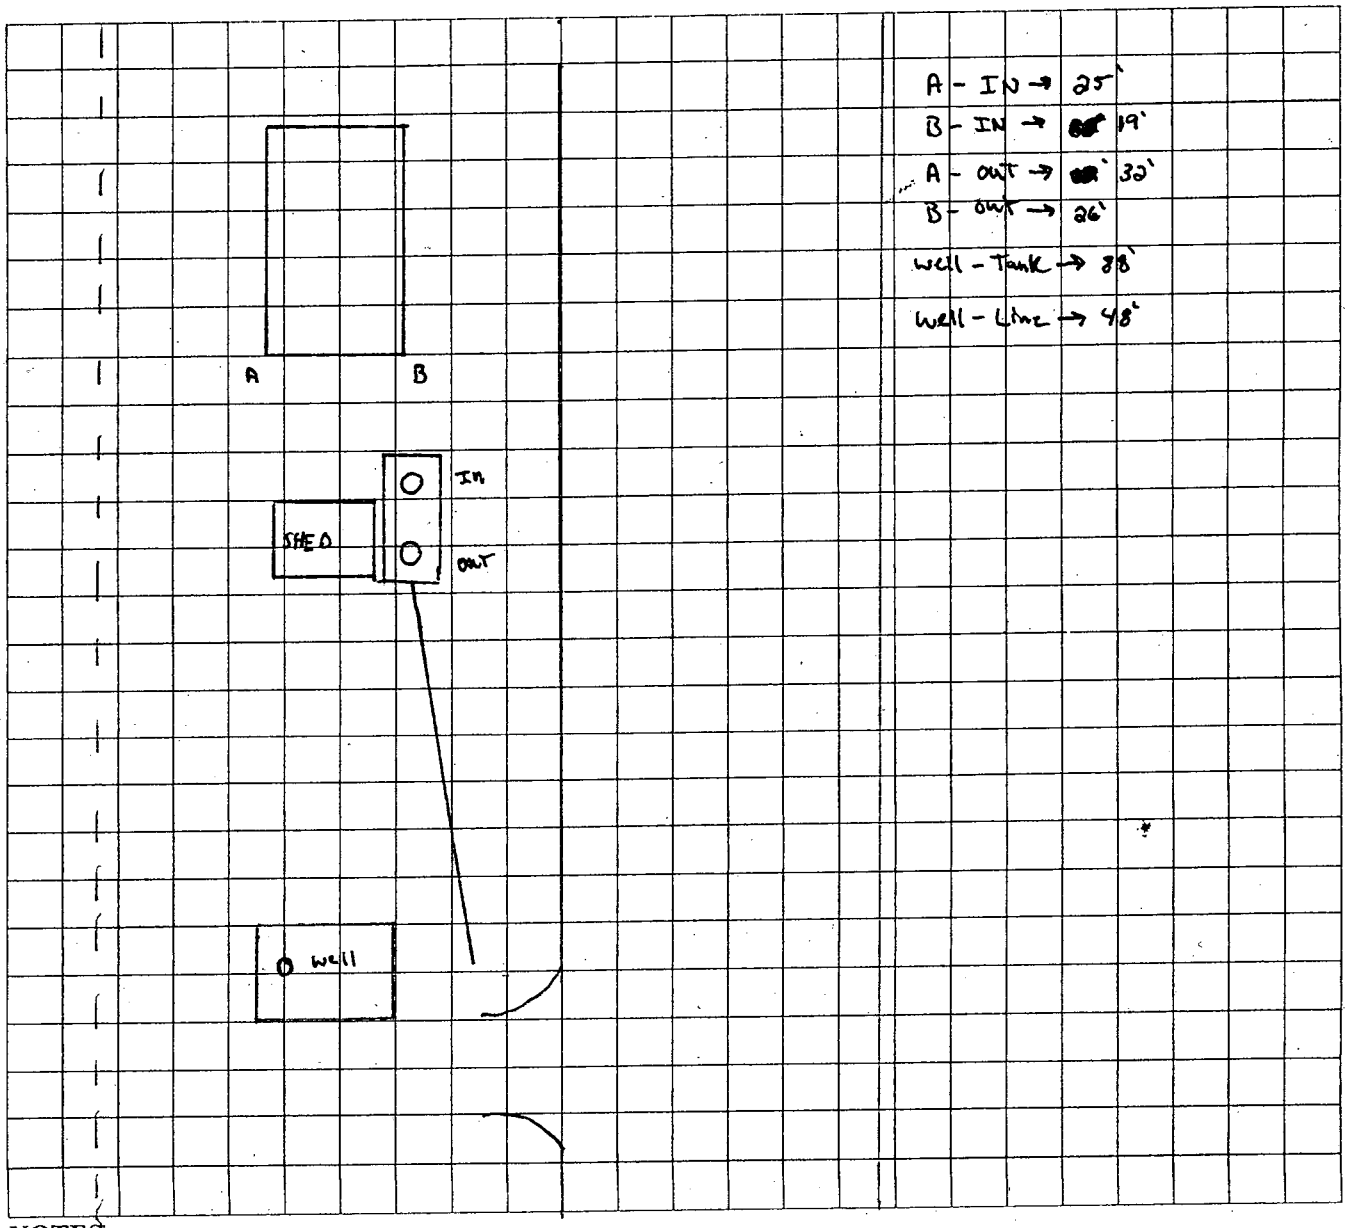
Septic System at 412 Woodview Dr. has a 750 gallon single compartment, concrete tank. Baffles are in place. The leach field consists of 20 feet of 4 inch perforated pipe and then to 4 inch tile. The 4 inch tile looks like it heads to the ditch but cannot see an outlet or discharge. A hydraulic load test was completed at 6 GPM for 85 minutes for a total of 510 gallons of water. System took water very well and did not surface. The tank is 85 feet from the water well, but leach line is only 47 feet from water well. Septic tank was pumped in November of 2013 by D & S Portables.

OWNER: Carolyn Boil **DATE:** 7/30/14
SITE ADDRESS: 412 Woodview Dr. **TOWN/COUNTY:** Dundee / Delaware
GPS: Long: Lat:
TANK SIZE: 750 Plastic **OR** (Concrete) **D-BOX:** 7 or 9 **OUTLETS USED:** None
SECONDARY TREATMENT: 1T leach line 4" Perf then 55' 4" Perf tile
could not get camera any Further (Dirt)
