REAL ESTATE TRANSFER - GROUNDWATER HAZARD STATEMENT

TIME OF TRANSFER INSPECTION MAP

Time of Transfer Inspection Report

NARRENTIVE INSPECTION REPORT
Premier Grain Property

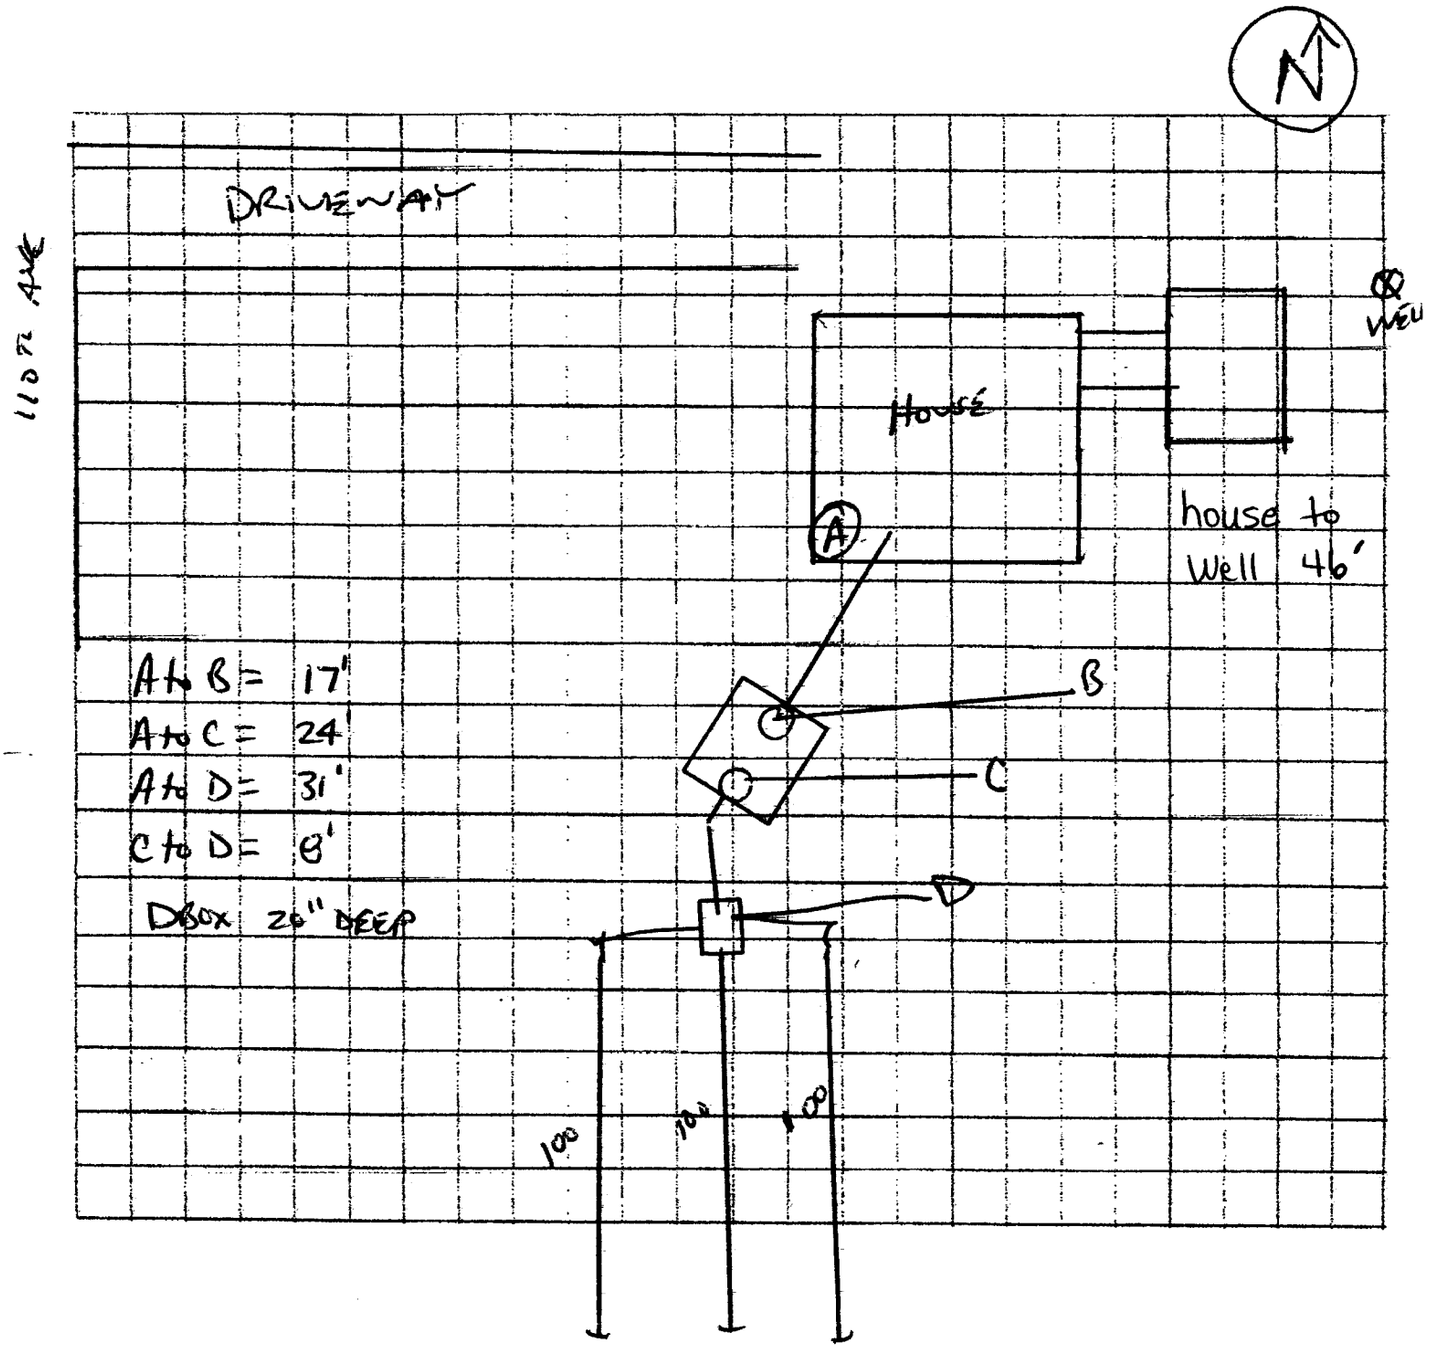
The primary treatment is a concrete septic tank which was pumped with 2" scum layer. The tank is suggested to be cleaned in 3 years. The septic tank does have two plastic risers to the surface. The septic tank liquid level was at the normal level, without any signs of high water or surge. The outlet exits the single compartment tank to a absorption system south of the home. There is a concrete/plastic lined distribution box that is in good condition.

The secondary treatment is a trench type chamber soil absorption system with three lines, 300 linear feet in size. A hydraulic load test was calculated for 250 gallons for this home, and completed with a garden hose from the out side facet for a time period of 38 minutes at 8.1 GPM. The absorption system took all the water without rising the flow line in the distribution box.
