REAL ESTATE TRANSFER - GROUNDWATER HAZARD STATEMENT
TO BE COMPLETED BY TRANSFEROR

Time of Transfer Inspection Report (DNR Form 542-0191)

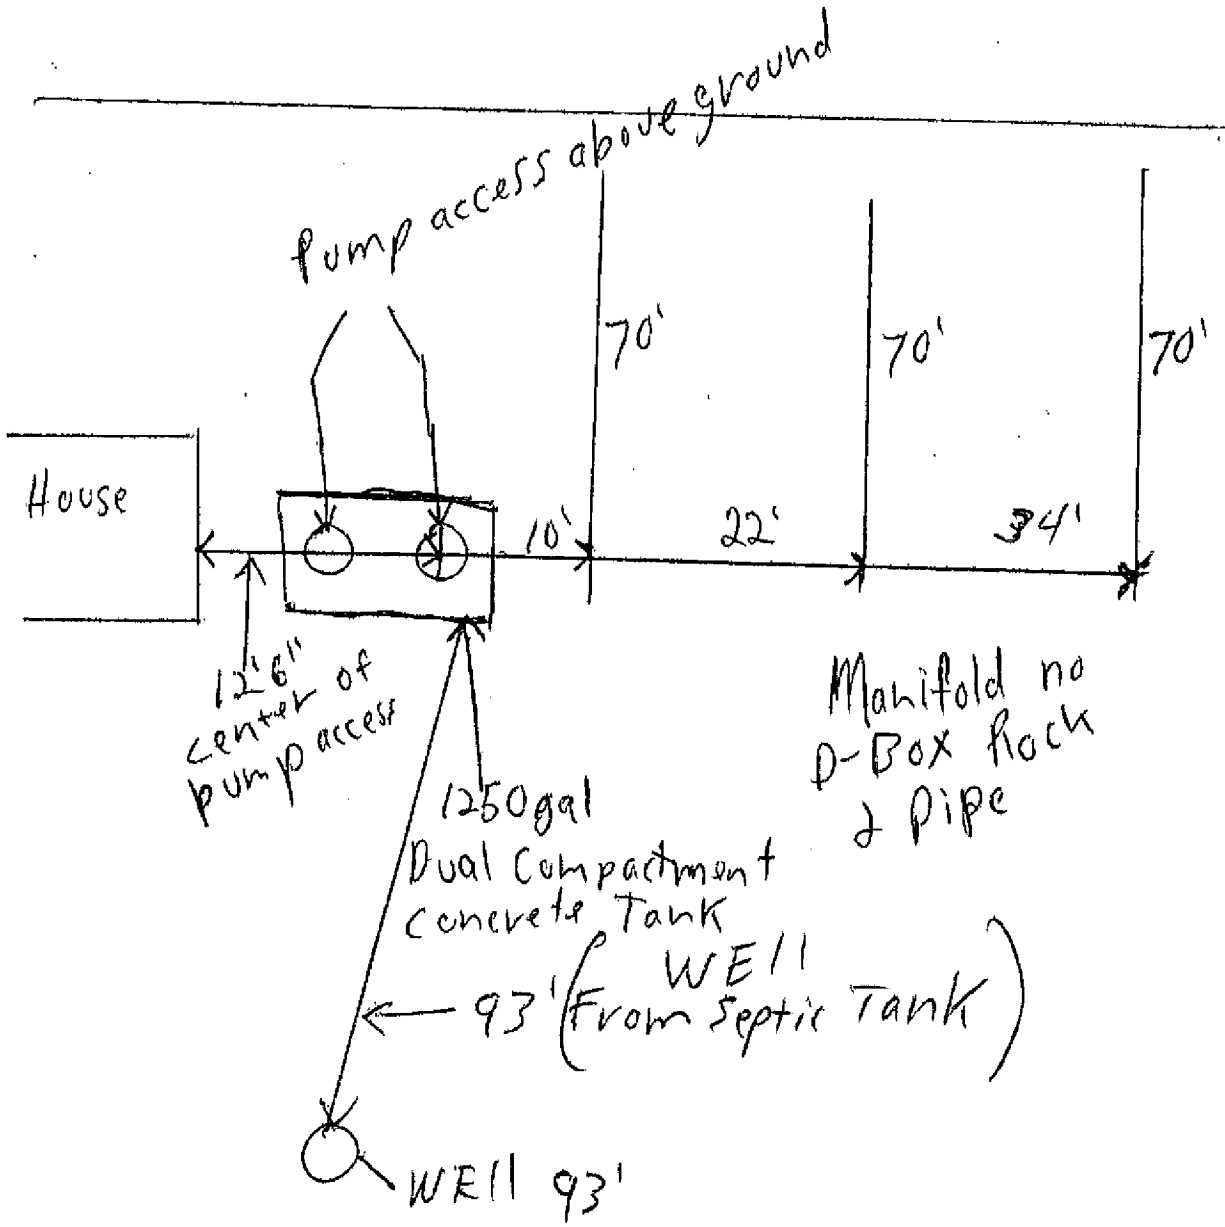
Comments: Look to Map for comments

Performed 50 min hydraulic test no rise in effluent in Header pipe. This system was in good working condition day of inspection.
