REAL ESTATE TRANSFER - GROUNDWATER HAZARD STATEMENT

20580 247th St	Delhi	IA	52223
Number and Street or RR	City, Town or P.O.	State	Zip

Time of Transfer Inspection Report (DNR Form 542-0191)

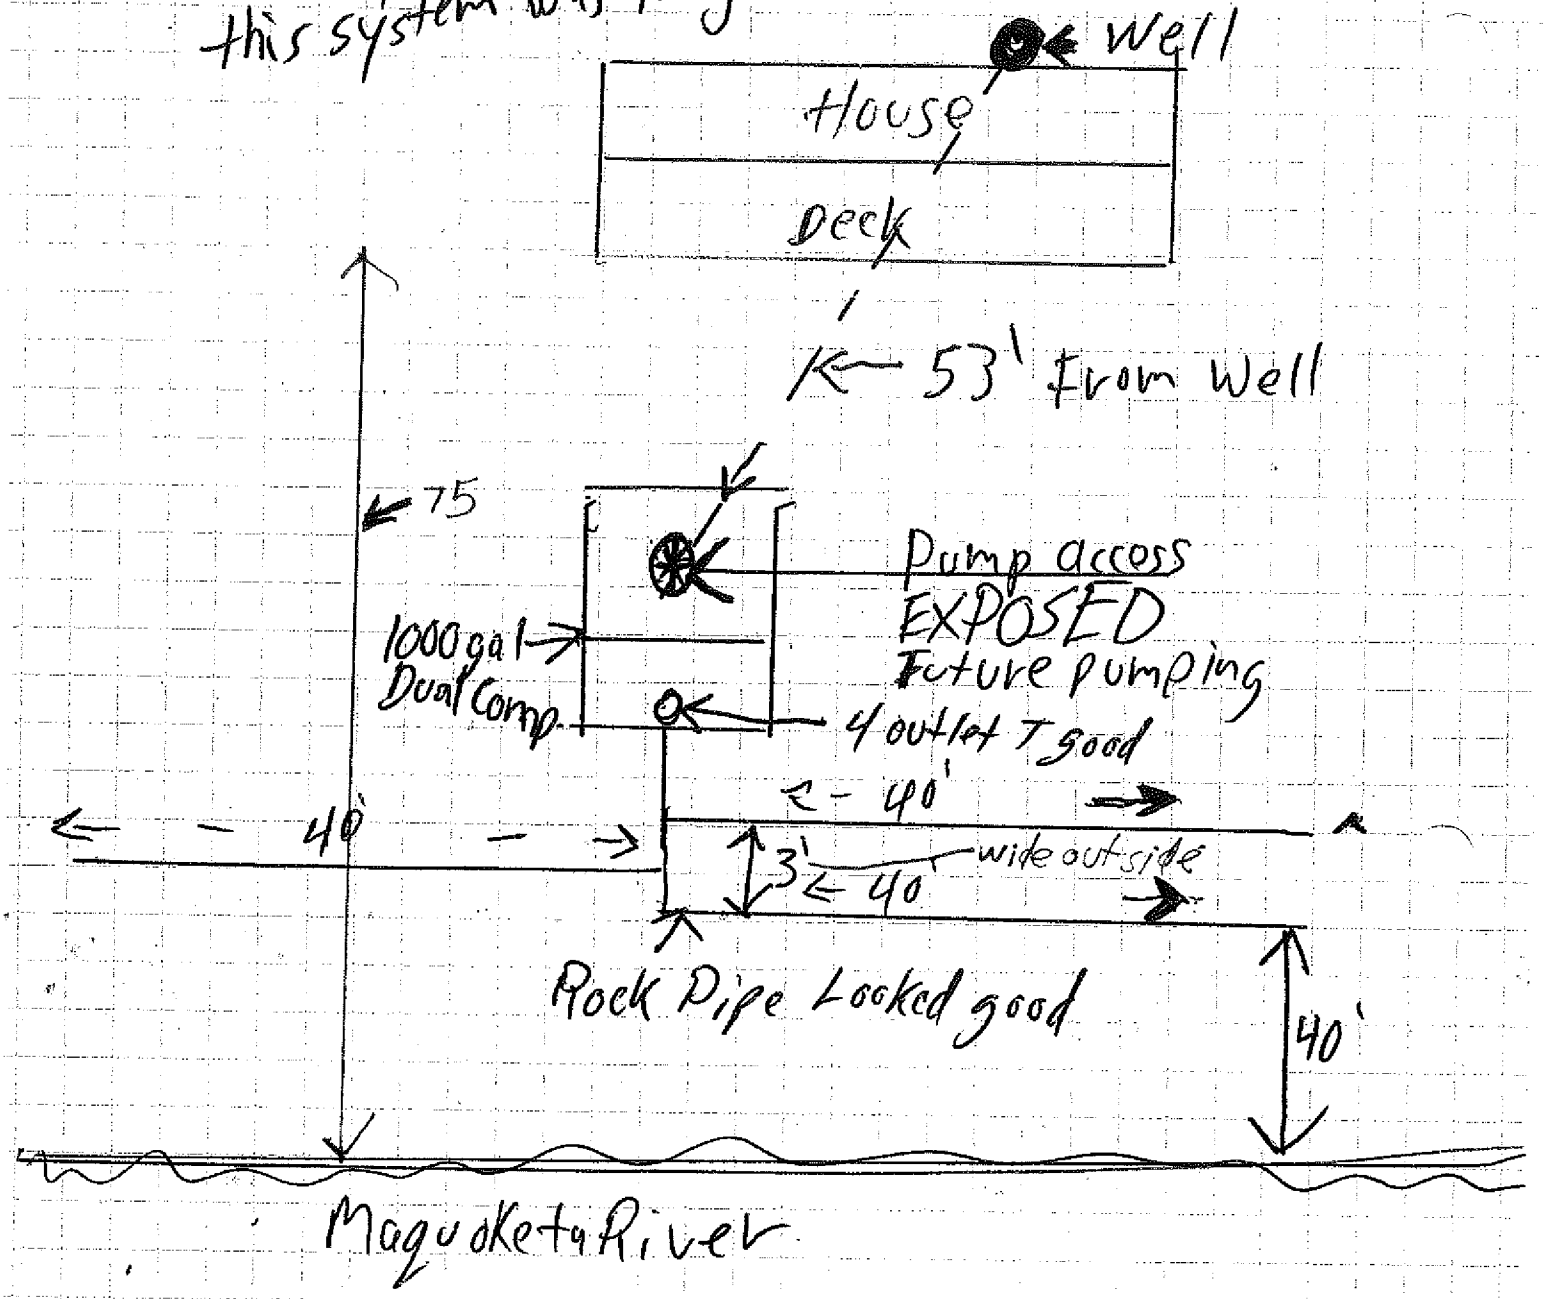
Comments: Look to Map for info

The day of Inspection this system was in good working condition

Performed 45 minute Hydraulic test
no rise in effluent in header pipe.
