REAL ESTATE TRANSFER - GROUNDWATER HAZARD STATEMENT

Time of Transfer Inspection Report

NARRATIVE INSPECTION REPORT
Rocky Nook Association Inc (WEST Septic System)

TIME OF TRANSFE
INSPECTION MAP

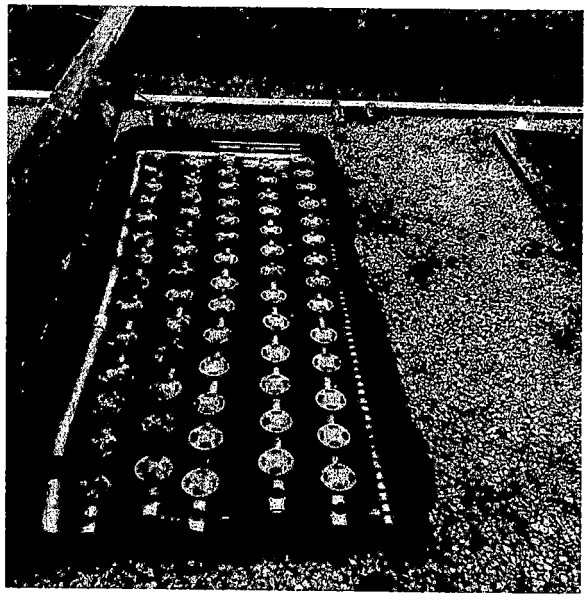
The septic tank has risers to the surface for each compartment, and does not need to be dug up. Normal septic tank cleanings are required every 3-5 years in order to keep these solids from flowing out into the absorption field. The septic tank is designed for storage of solids in the first compartment and pumped out according to the size and use of each home. There was no scum layer, and very little solids at the bottom of the tank. The inlet and outlet baffles are plastic and are in good condition.

A hydraulic load test was not completed, as the requirement for this inspection is to test components and run some pump cycles. Tested all pumps and controls and were working correctly on the day of inspection. The pods look normal, and there is no outlet discharge to test for BOD,and TSS as it has been dry.

There are pictures included in this report of the system components. Also a map has been drawn as part of this inspection.(Tank capacity was verified by Digital Tank Gauge)
