REAL ESTATE TRANSFER - GROUNDWATER HAZARD STATEMENT

Time of Transfer Inspection Report

Comments: Inspection for 1 of 3 centralized septic systems (WEST) RTU#130109

NARRATIVE INSPECTION REPORT
Rocky Nook Association Inc (WEST Septic System)

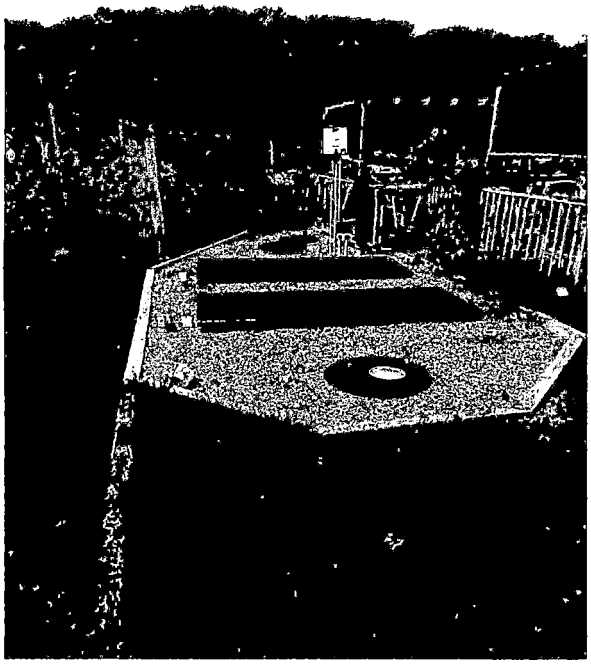
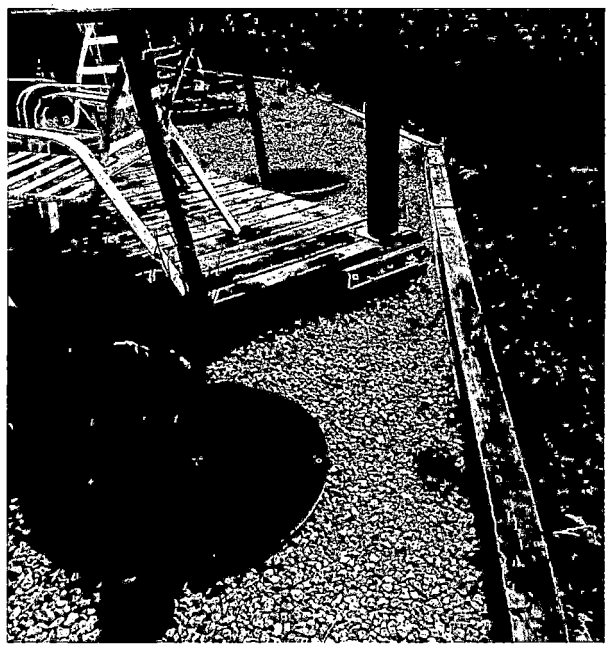
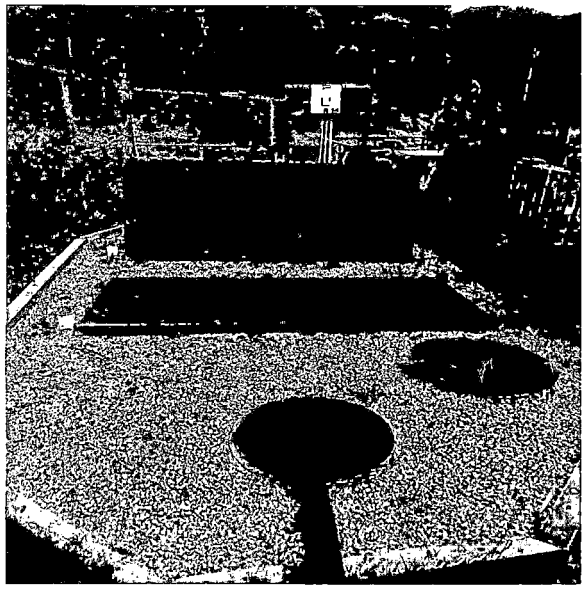
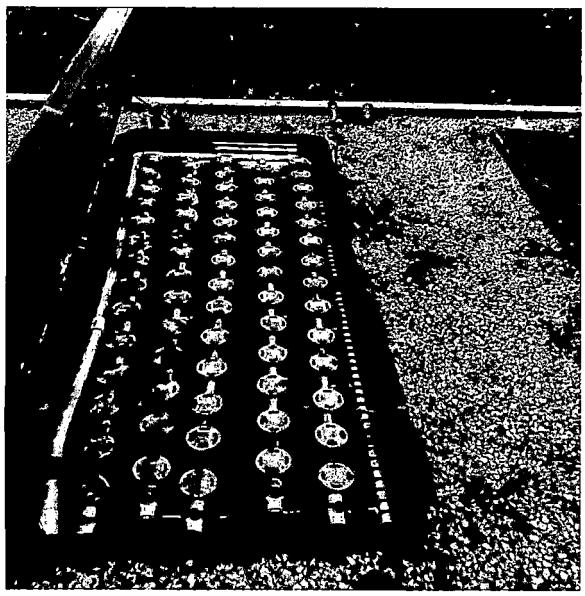
The septic tank has risers to the surface for each compartment, and does not need to be dug up. Normal septic tank cleanings are required every 3-5 years in order to keep these solids from flowing out into the absorption field. The septic tank is designed for storage of solids in the first compartment and pumped out according to the size and use of each home. There was no scum layer, and very little solids at the bottom of the tank. The inlet and outlet baffles are plastic and are in good condition.

A hydraulic load test was not completed, as the requirement for this inspection is to test components and run some pump cycles. Tested all pumps and controls and were working correctly on the day of inspection. The pods look normal, and there is no outlet discharge to test for BOD,and TSS as it has been dry.

There are pictures included in this report of the system components. Also a map has been drawn as part of this inspection.(Tank capacity was verified by Digital Tank Gauge)
