REAL ESTATE TRANSFER - GROUNDWATER HAZARD STATEMENT
TO BE COMPLETED BY TRANSFEROR

Time of Transfer Inspection Report (DNR Form 542-0191)

Time of Transfer Report System Status

Address: 2203 196th of Winter Set

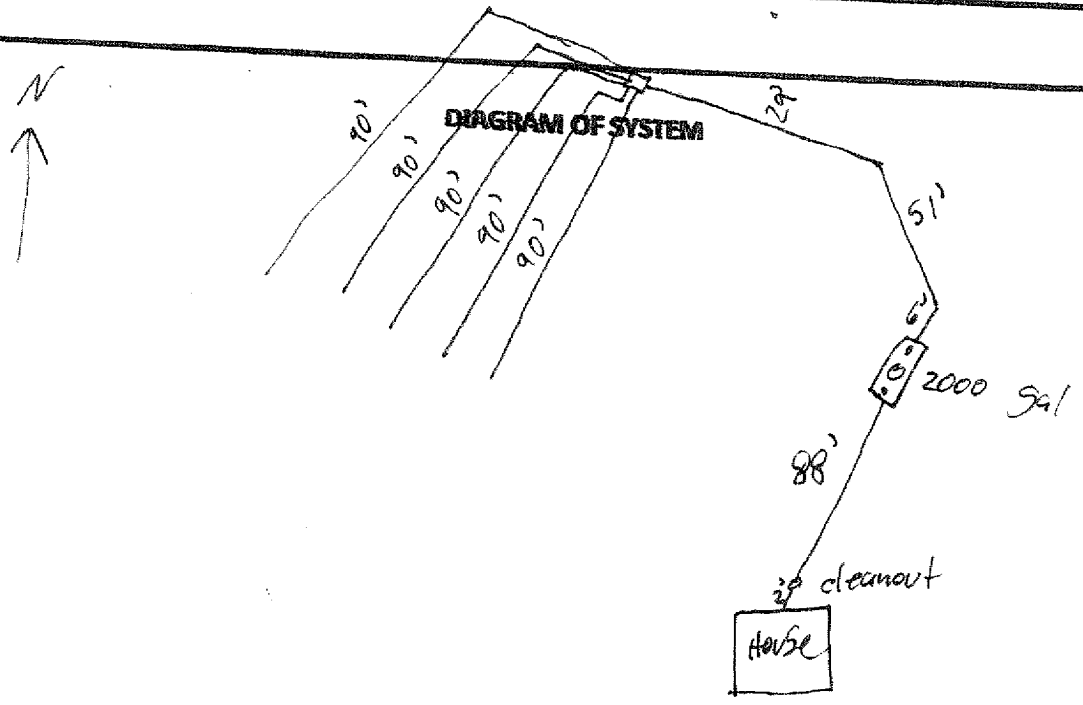
All waste water goes from house to septic system. 2000 gallon concrete tank is in good working condition with no cracks and is water tight. ~~Plastic~~ Plastic distribution box is cracked and is not water tight. 5 chamber laterals all probe dry at the time of inspection. Ran 450 gallons of water to perform a hydrolic test. All laterals took water.
