**REAL ESTATE TRANSFER - GROUNDWATER HAZARD STATEMENT
TO BE COMPLETED BY TRANSFEROR**

TIME OF TRANSFER INSPECTION TOT# 7871 DUSTIN TROMBLAY CERT # 12293

Address: **3279 330th St, Truro, IA 50257**

.. Permit # 036-06 Minnick Inspection 5/25/06

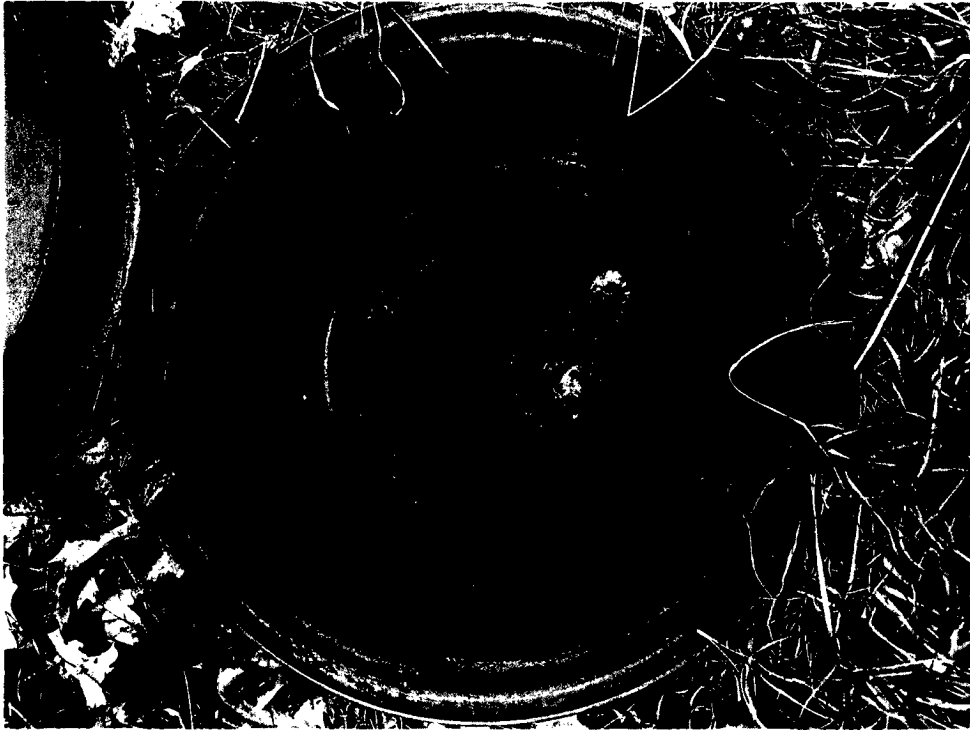
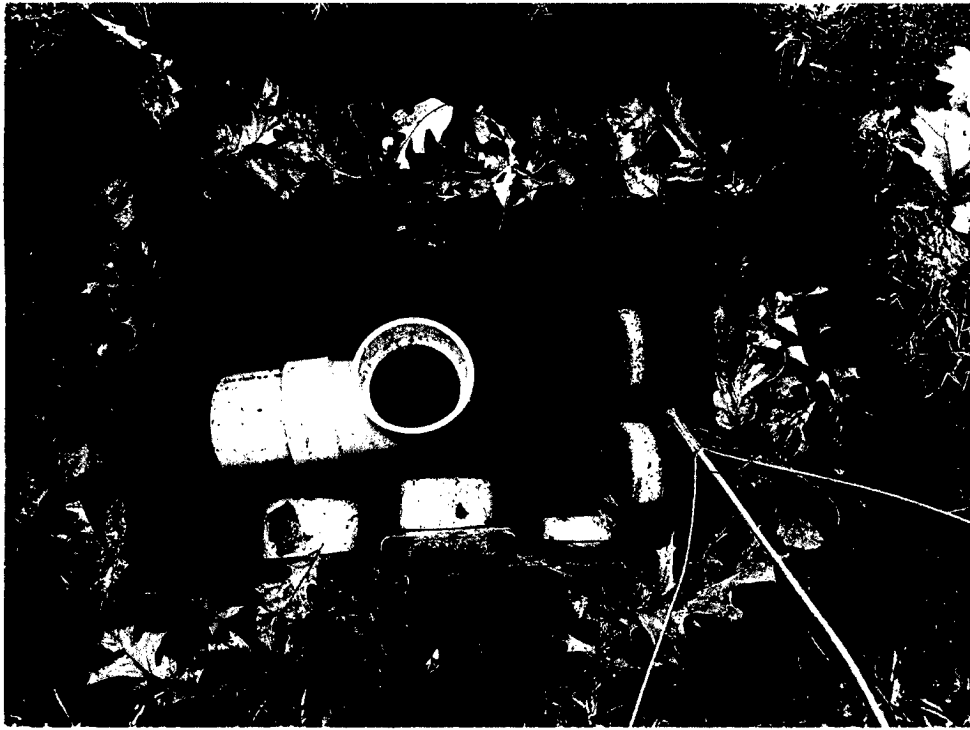
TOT Inspection Report Overall Narrative Comments: **Septic tank was pumped at time of inspection and is in good condition at this time with inlet and outlet baffle present, effluent filter present, and no noticeable cracks or breaks. Riser and lid on inlet side have chips on the edges but appear to be water tight. Distribution box is in good condition at this time with baffle present, speed levelers present, and no cracks or breaks. Laterals were probed to ensure proper length and appear to be in good condition at this time with no evidence of septic surfacing. There is currently no access to water at this location so a load test was unable to be completed.**
