**REAL ESTATE TRANSFER - GROUNDWATER HAZARD STATEMENT  
TO BE COMPLETED BY TRANSFEROR**

**Time of Transfer Inspection Report (DNR Form 542-0191)**

Site Address/County 2398-Cumming Rd. Winterset, Mo. 65273 Madison Co -  
Legal Description \_\_\_\_\_

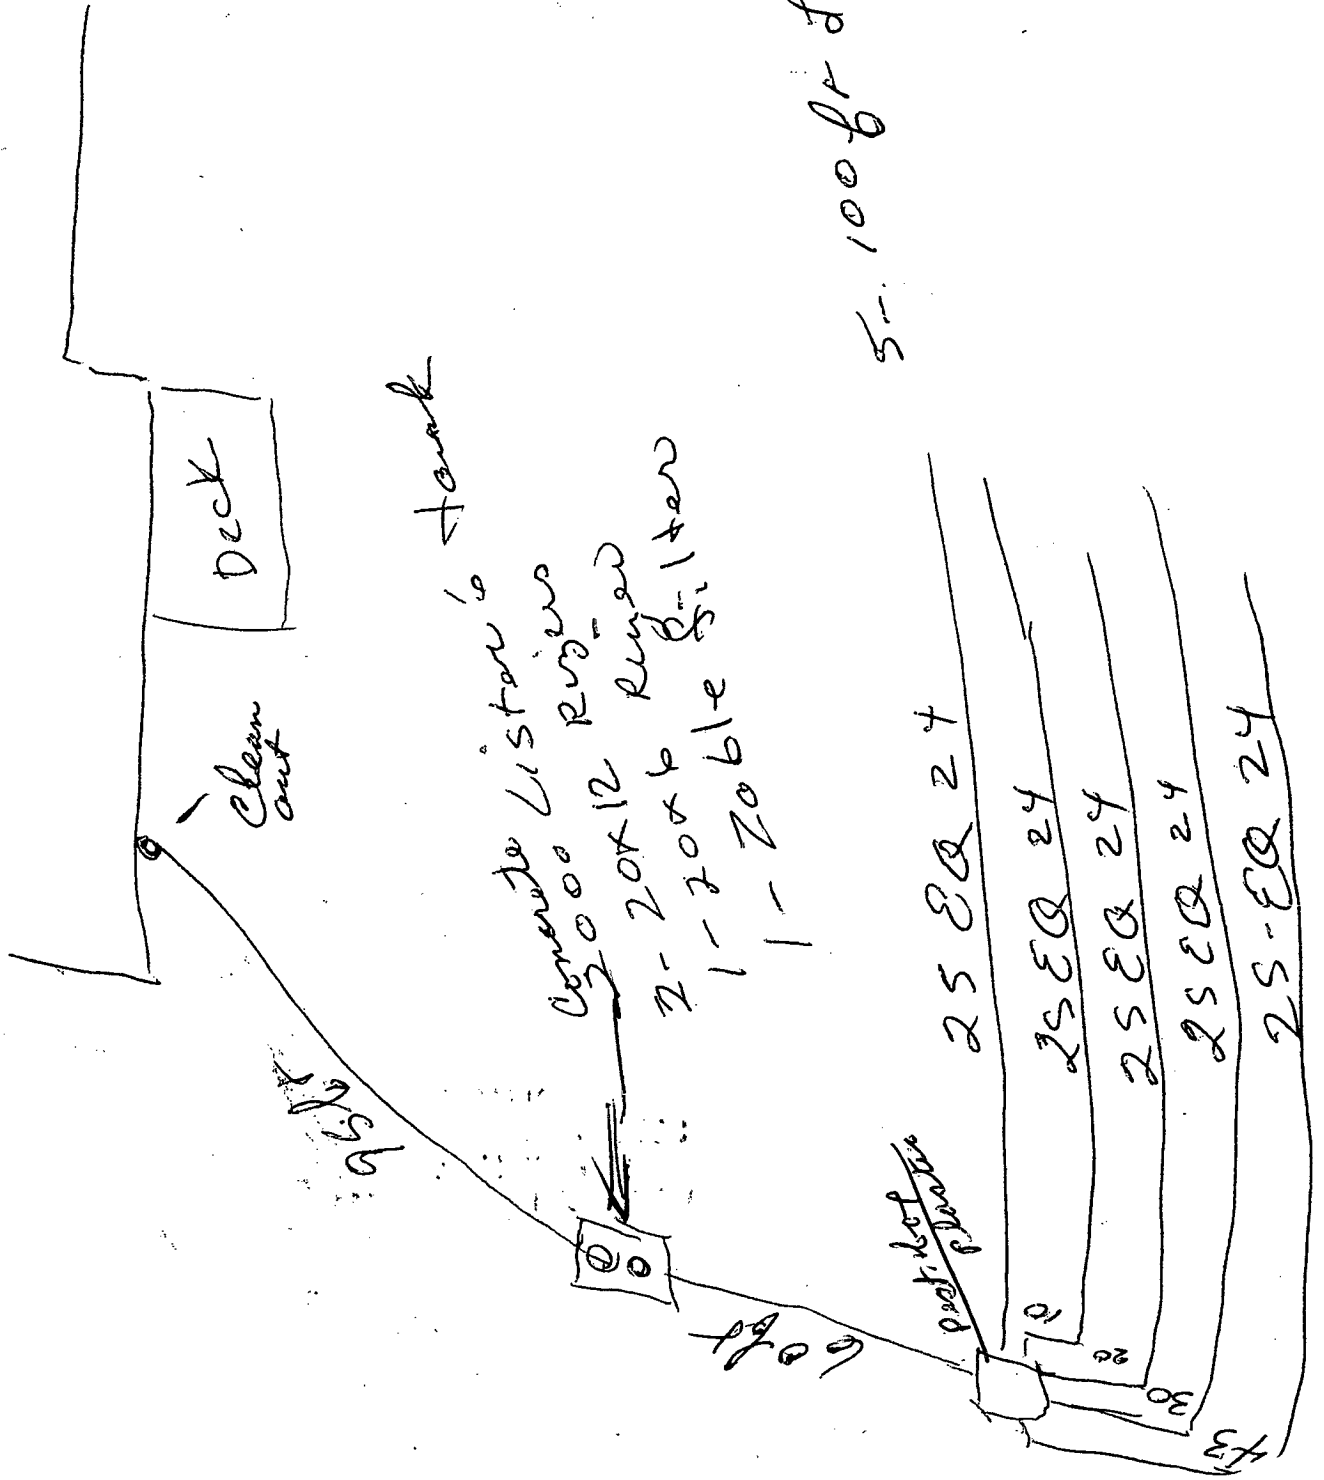
Randy Jordan  
Copper Estates  
FOX Estates

Report system status The septic system at 2398 Cummins Rd Winterset, Ia is in Very good Cond. the septic tank was Pumped on 9-28-10 - also no cracks in tank Explain (attach additional pages as needed): also tank has two compartments in tank & cut flow baffles are in place - on 9-28-10 - tank was added water to lateral field

Comments: Took water & none came to ground surface on 9-28-10 - also lateral hop was uncovered & opened & was in good Cond. also all gray water goes to septic tank on 9-28-10 -

5- 100 ft lines
