**REAL ESTATE TRANSFER - GROUNDWATER HAZARD STATEMENT  
TO BE COMPLETED BY TRANSFEROR**

Time of Transfer Inspection Report (DNR Form 542-0191)

### Time of Transfer Inspection Report

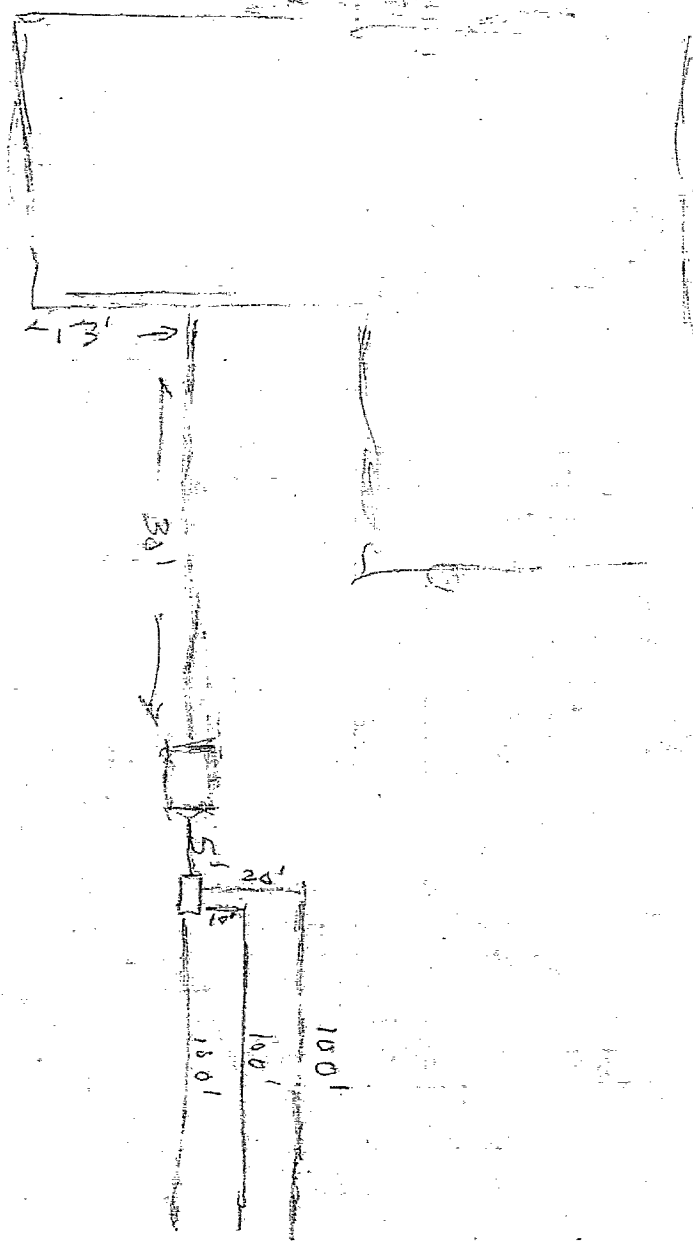
Permit 1148  
2770 Hwy 92

Report system status The system at 2770 - is no good for

Explain (attach additional pages as needed): use at this time -  
The concrete tank is bad on outlet end (concrete is eat away)

Comments: also concrete baffles are gone - also concrete  
distr. box is falling + is no good - the lateral field is  
clean and dig - field is rock + pipe also all grey water  
goes to Tanks on 4-26-12
