## **REAL ESTATE TRANSFER - GROUNDWATER HAZARD STATEMENT**TO BE COMPLETED BY TRANSFEROR

# **Time of Transfer Inspection Report**

5/14/13
Time of Transfer Inspection
1348 Nature Court Van Meter, IA 50261

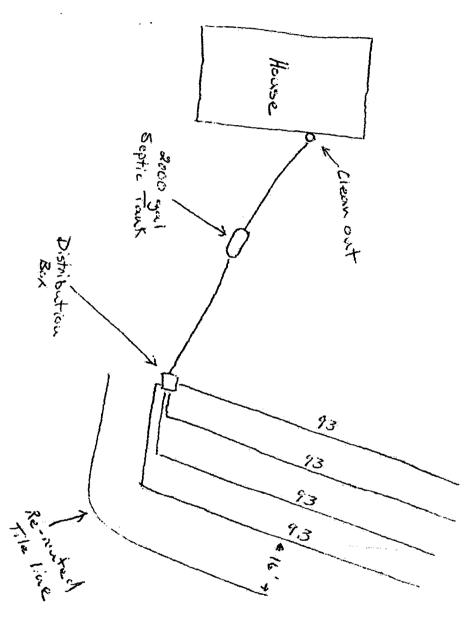
The system consists of one 2000 gallon concrete septic tank, a poly distribution box and lateral field. The lateral field consists of four 93' trenches with chambers. The d-box was excavated and appears to be in good condition. During the stress test water flowed through the system properly with no changes in water level in the septic tank and no back flow from the lateral lines to the d-box. During the inspection of the lateral field some saturation was evident over the fourth lateral line. The levelers in the d-box were adjusted to reduce the flow to that lateral and more equally distribute effluent to the field. That should eliminate the saturation problem in that area. Overall the system appeared to be working properly at the time of the inspection.
