REAL ESTATE TRANSFER - GROUNDWATER HAZARD STATEMENT TO BE COMPLETED BY TRANSFEROR

Time of Transfer Inspection Report

DNR Time of Transfer Report System Status

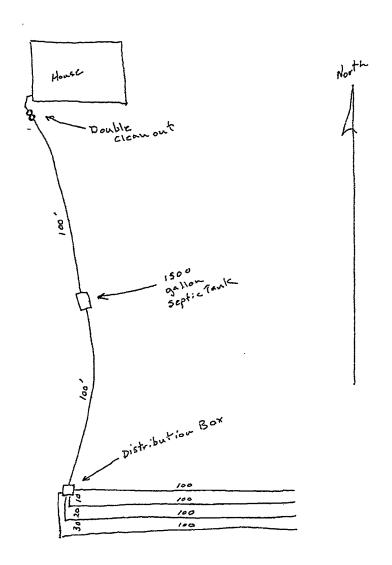
Address: 3164 140 thst.	_Date:	7+1-14
Address: 3164 140 thst. Comments: Technician L All waste water from house drains	Brien	Rinard
All waste water from house drains	+0	
septic system.		
The tonk is a 1500 gal. Conc	rete	tank
in good condition. The Distribution Fox 4 211	atan	-1,
The Distribution Fox 4 all lever in good working condition.	wer	ίζς
The good port of the contraction		
This is not a guarantee		
This centifies that the septic	54	rtem
was in pool working andition at		re_
Time A-V the inspection.		···
		······································
DIAGRAM OF SYSTEM		
LO MAN OF SYSTEM
