**REAL ESTATE TRANSFER - GROUNDWATER HAZARD STATEMENT  
TO BE COMPLETED BY TRANSFEROR**

**Time of Transfer Inspection Report (DNR Form 542-0191)**

Site Address/County 1534-120th St. Earlham, Ia. 50072  
Legal Description \_\_\_\_\_ Madison Co.

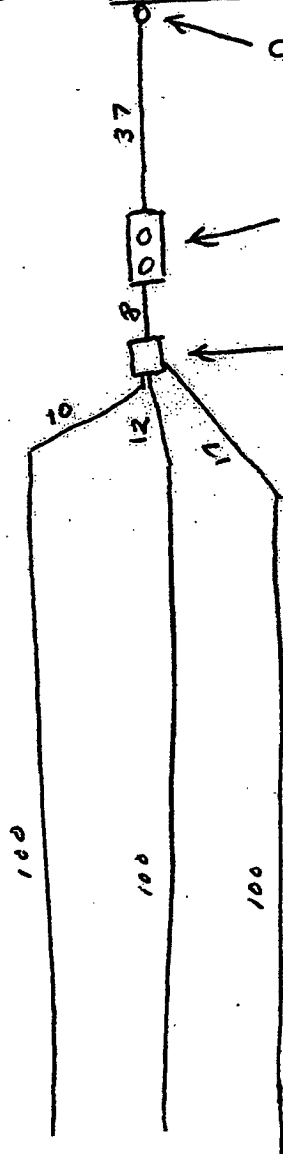
Permit # 020-05 Kalkhoff Inspection 3/18/05

← Clear out

← 1000 gal Plastic  
Septic Tank

← Distribution  
Box  
Plastics
