**REAL ESTATE TRANSFER - GROUNDWATER HAZARD STATEMENT
TO BE COMPLETED BY TRANSFEROR**

Time of Transfer Inspection Report

DNR Time of Transfer Report System Status

Address: 3359 135th Ct, Date: 3-16-16
Cumming Ia. 50061 Technician Tory Forest

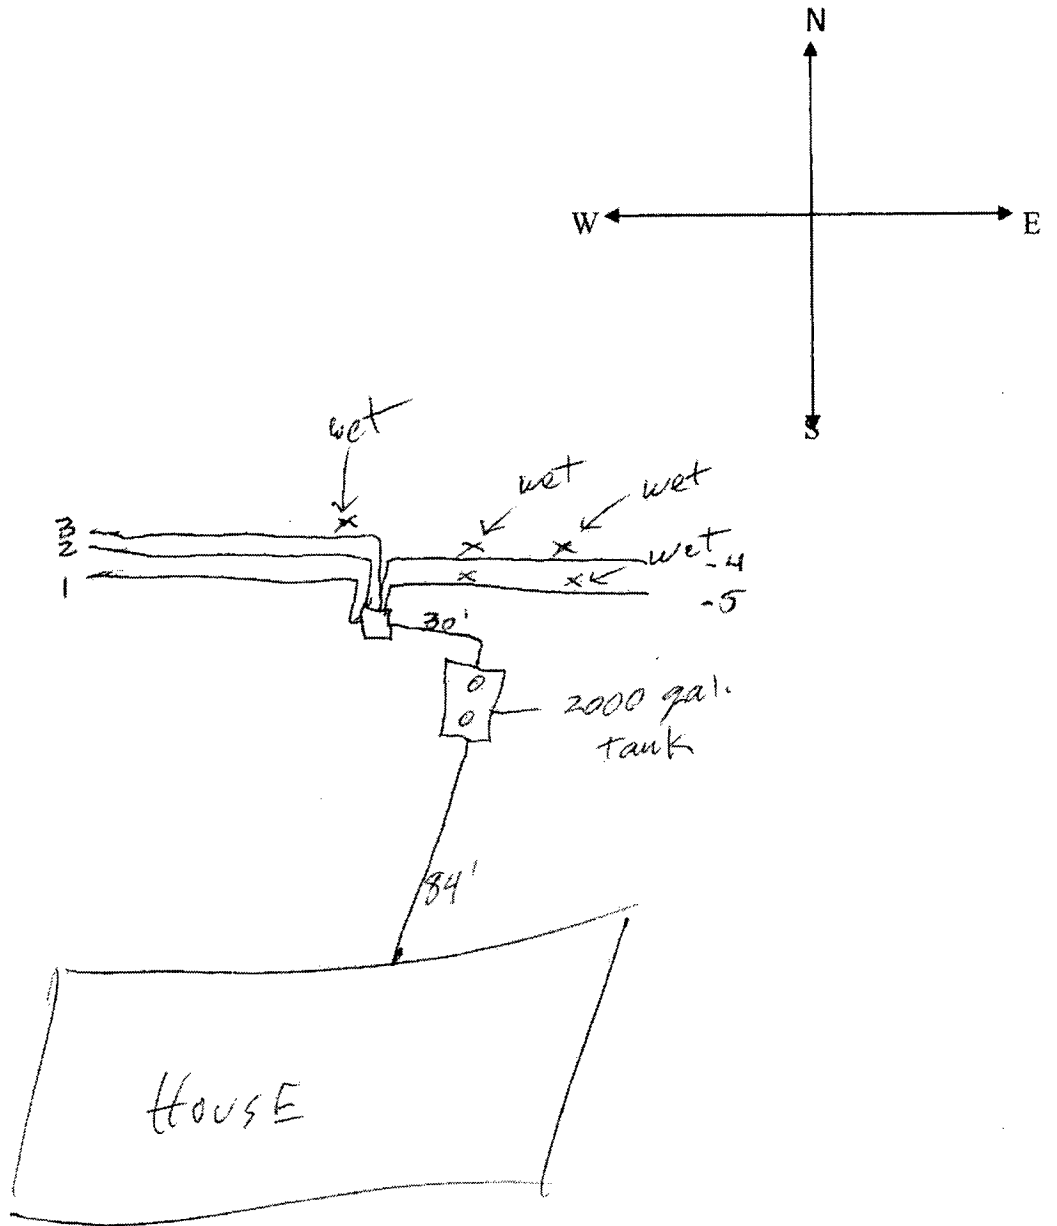
DIAGRAM OF SYSTEM

Condition of fields: probed wet (see attached) Determined by: Hydraulic Test and Probing

Report system status: laterals probed wet (see attached)

Remarks: All 5 laterals probed wet at the time of the inspection. The beginning of #1 lateral was wet at the surface, (see drawing). Number 4 & 5 laterals were also wet on the down hill side of each lateral, (see drawing). NOTE: we adjusted the Distribution Box during the inspection however all laterals probed wet. Also, down spout appears to be draining onto lateral area.
