**REAL ESTATE TRANSFER - GROUNDWATER HAZARD STATEMENT  
TO BE COMPLETED BY TRANSFEROR**

1408 Quail Ridge Avenue, Van Meter, IA 50261

**Time of Transfer Inspection Report (DNR Form 542-0191)**

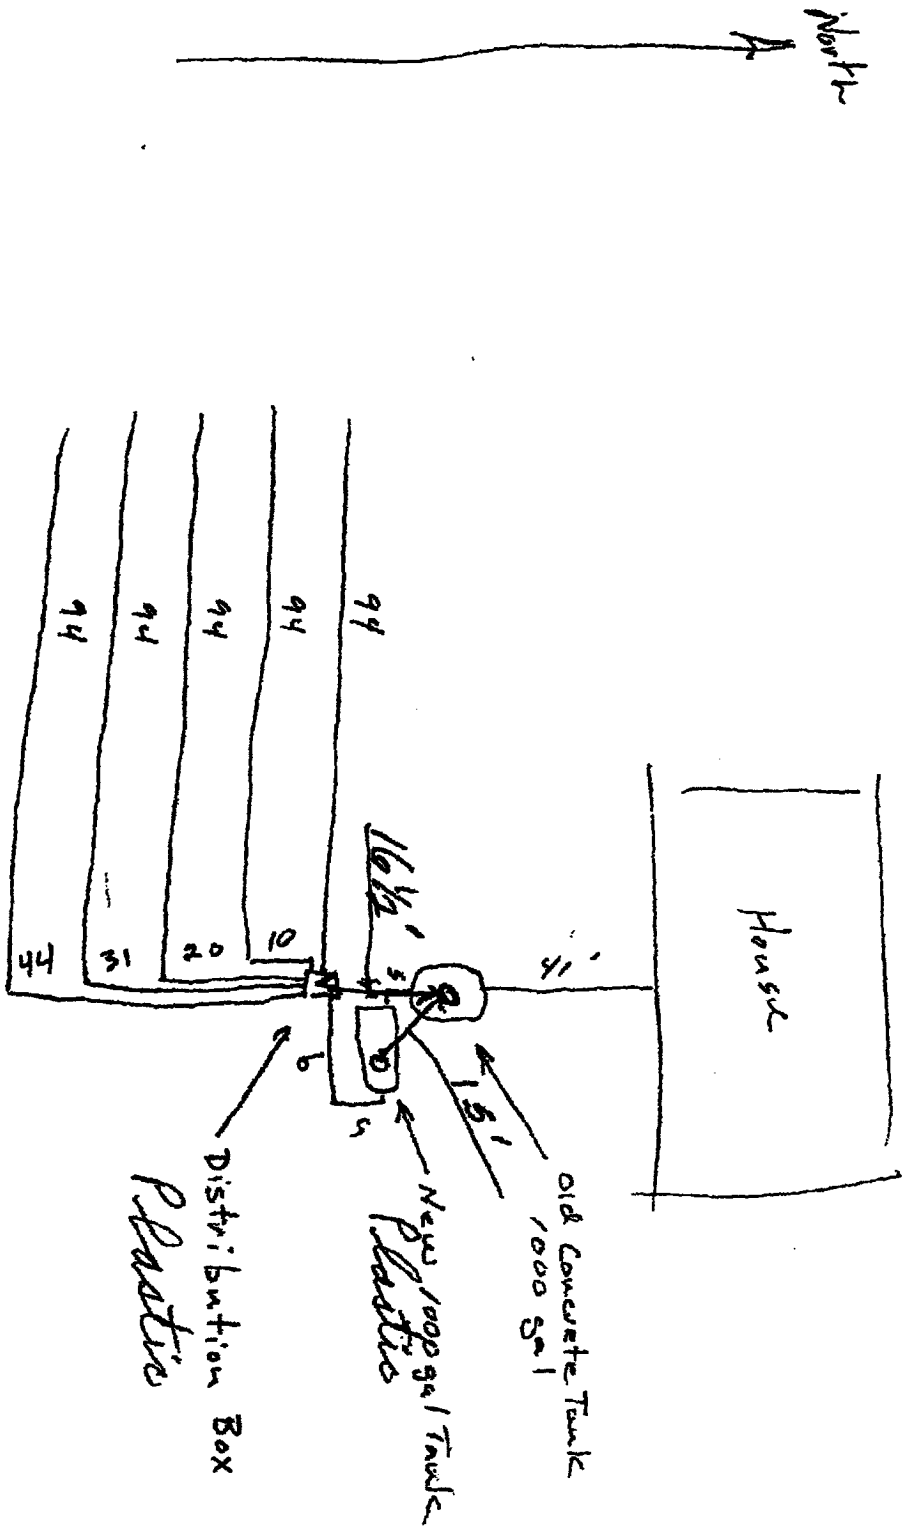
Permit # 113-03 Town Herald Inspection 10/10/03  
1408 Quail Ridge Ave.

length of absorption fields 94' determined by map & probing  
condition of fields good & dry determined by walking & probing  
type of trench material Chamber

Comments: The (2) septic tanks were pumped on 10/10/16  
 the tanks are good cond. no cracks in tank slab  
 water at correct level before pumping.  
 All gray water goes to system on 10/10/16  
 The tank has (2) compartment intake & outflow baffles in place.  
 The distribution was opened & all laterals took water  
 but not in good cond.
