**REAL ESTATE TRANSFER - GROUNDWATER HAZARD STATEMENT  
TO BE COMPLETED BY TRANSFEROR**

Address of Property Transferred:  
1812 Millstream Court, Winterset, IA 50273  
Number and Street or RR City, Town or P.O. State Zip

### Time of Transfer Inspection Report

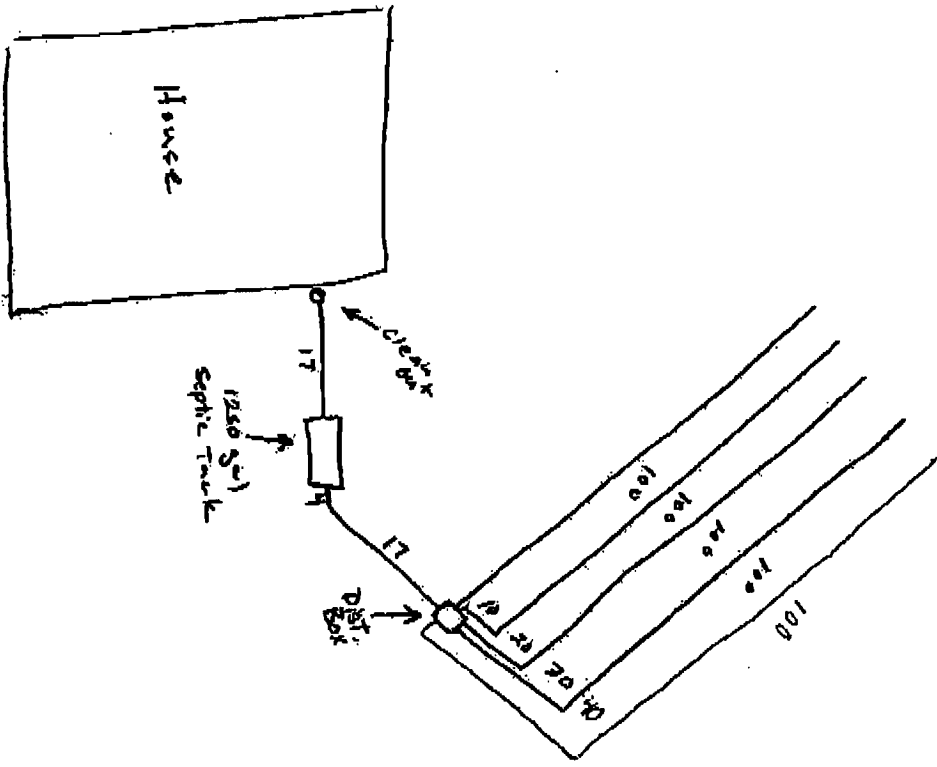
# 097-06 Sewer  
 1<sup>st</sup> Inspection  
 5<sup>th</sup> line added  
 Lot 43 Covered Bridge Estates  
 9/15/06  
 5-11-D7

North  
 5B  
 8-8-17
