**REAL ESTATE TRANSFER - GROUNDWATER HAZARD STATEMENT
TO BE COMPLETED BY TRANSFEROR**

Time of Transfer Inspection Report (DNR Form 542-0191)

Site Address/County 1569 105th St, Earlham Madison Co

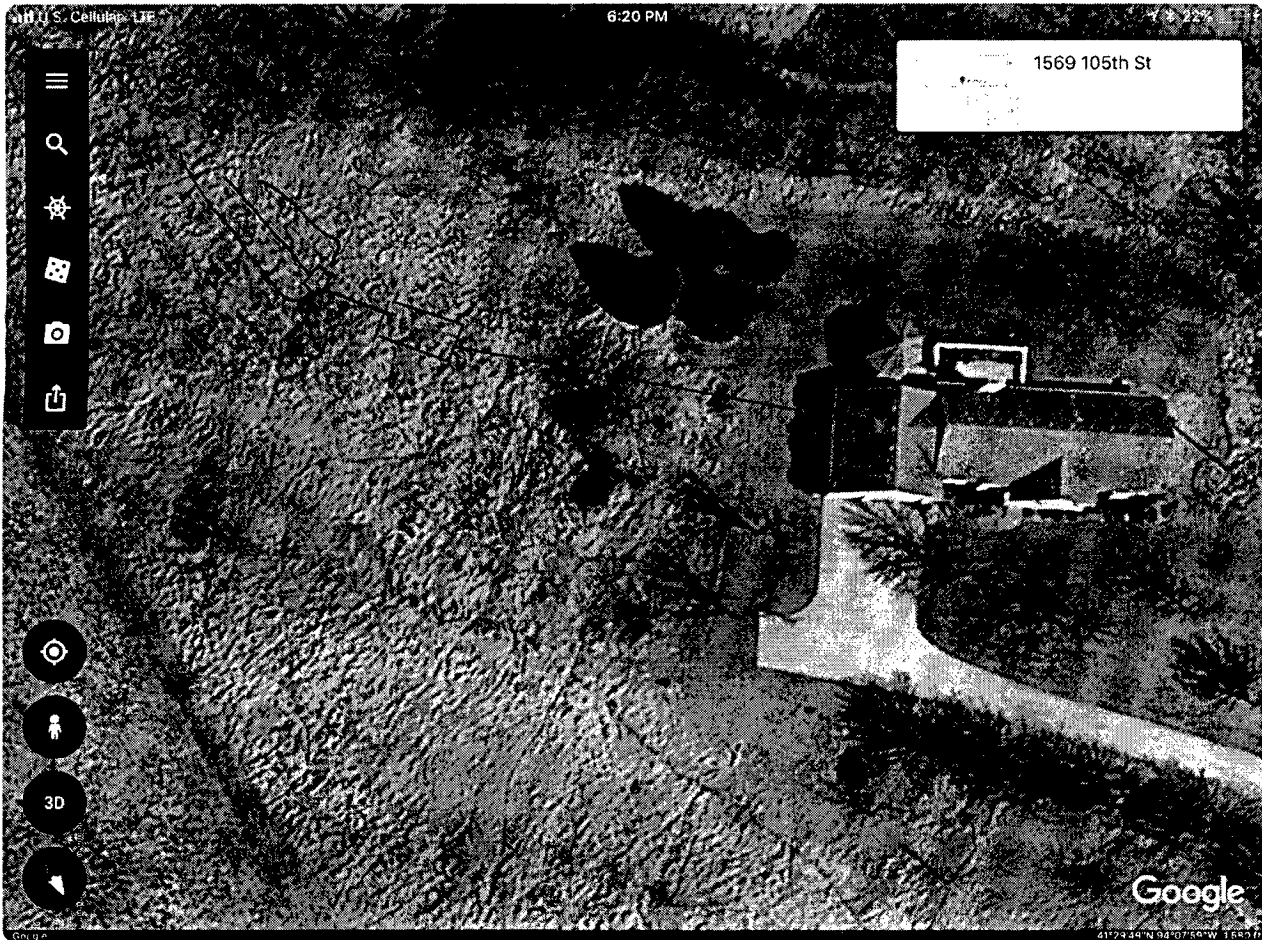
Explain (attach additional pages as needed): All waste water goes from house to septic. 1250 gal plastic tank with risers and baffles in working condition. Plastic distribution box in working condition. Hydraulic load tested the 3x100ft=300ft rock and pipe laterals with 300 gal water. All laterals took water and probed dry and clean.

- 1) 1250 gal plastic tank
- 2) Plastic distribution box
- 3) 3x100ft=300ft rock and pipe laterals.

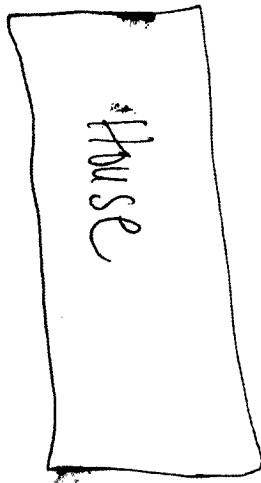
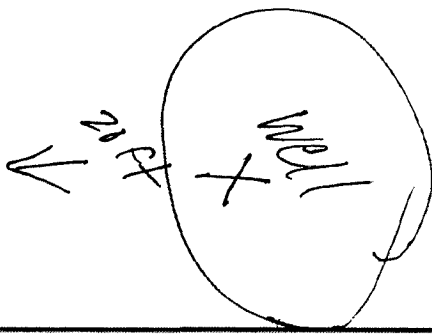
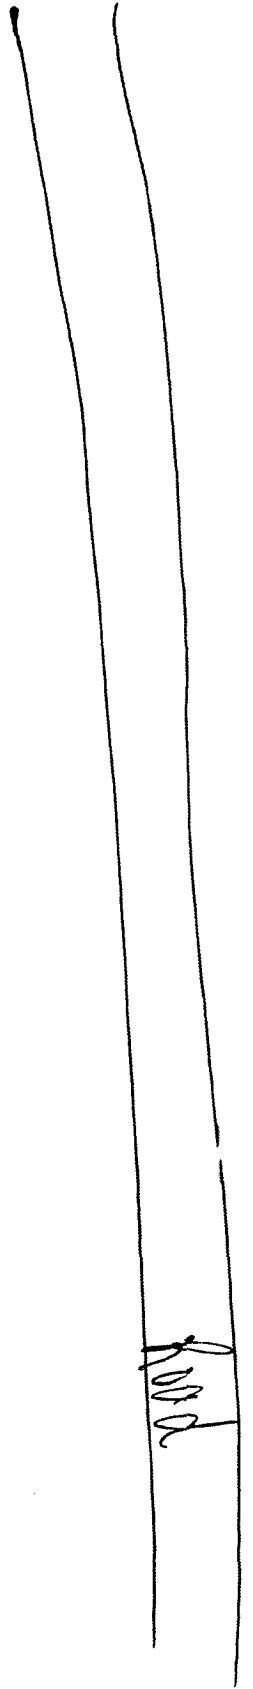
Well location
1509 105th St Earlham

road
